The Great Tower of St, Albans Abbey Church.

With a description of repairs recently carried out among its ancient timbers.

BY JOHN C. ROGERS, A.R.I.B.A.

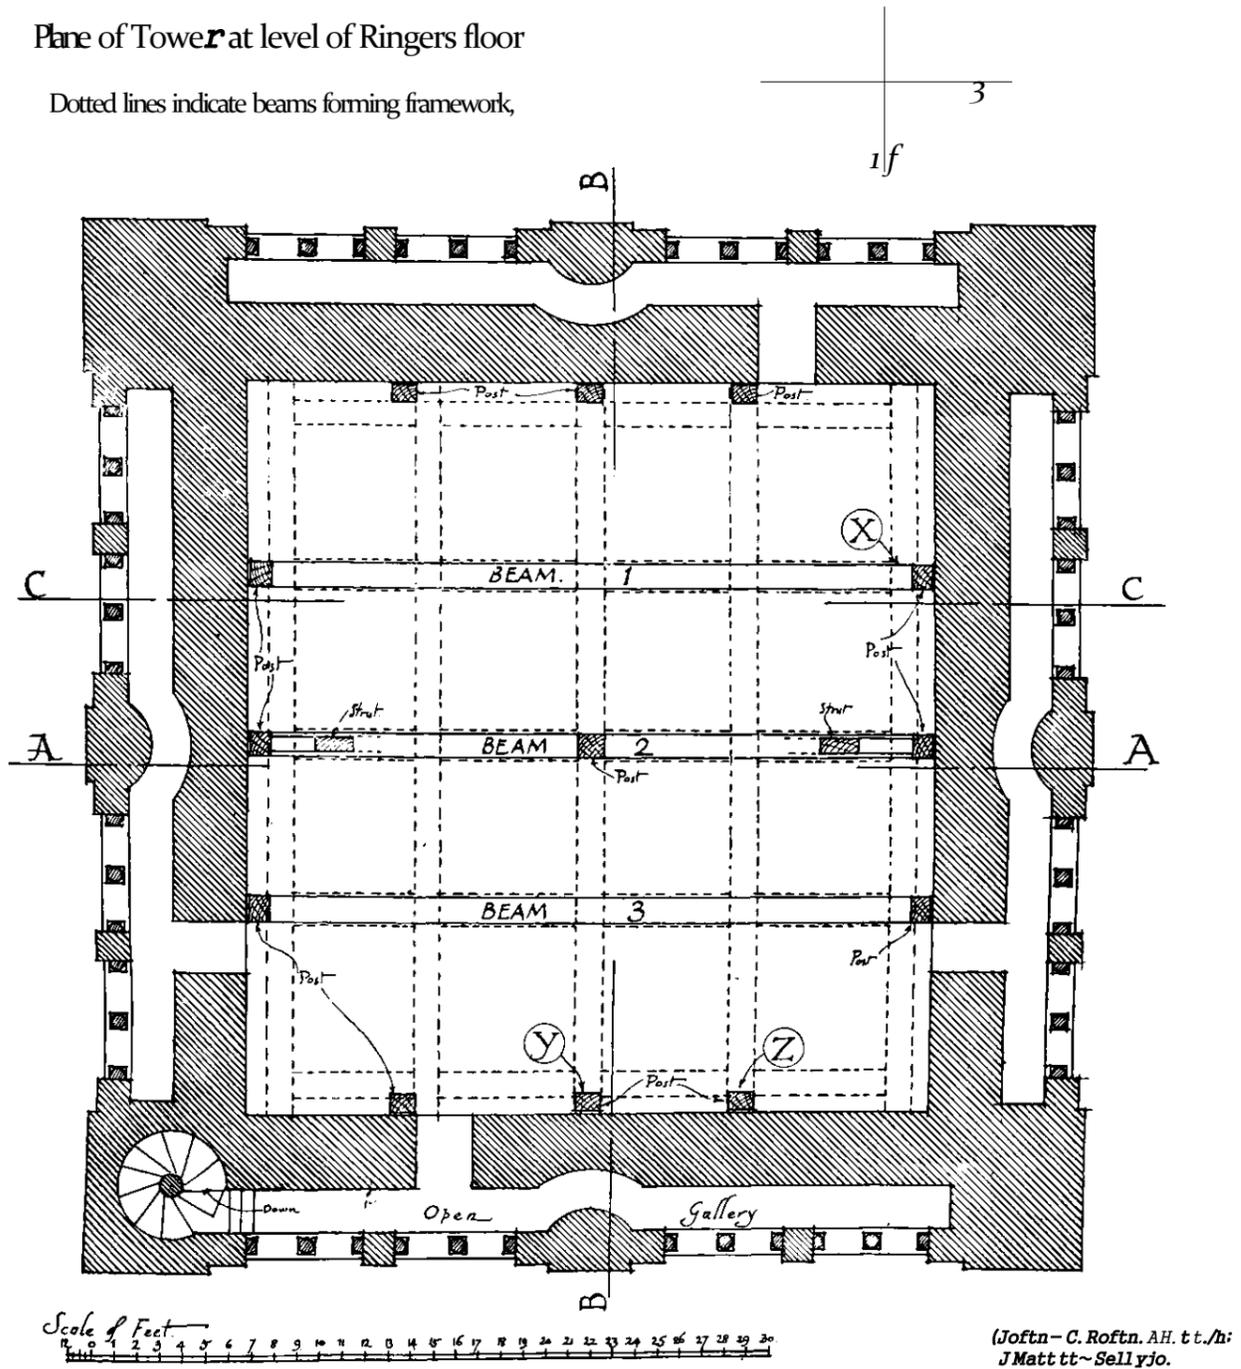
PLATE I.

St ALBANS ABBEY CHURCH
 Plan of Tower at level of Ringers floor

At the time of my survey in May, 1930, it was possible only to surmise what lay beneath the boards forming the floor of the ringing chamber, or what relation the framing of the panelled ceiling had to the three beams (figured 1, 2, 3, on the plan) projecting slightly above the floor boards. My report advised exposing the ends of these beams entirely by removing a portion of the flooring and by cutting away the wall around them. This preliminary work led to unexpected discoveries.

The ends of beams 1, 2 and 3 were found to penetrate but short distances into the walls—no more than from six inches to nine inches—pointing in unmistakable manner to some other form of support which at that juncture was not visible.

At point X on the plan the end of the floor beam and foot of the upright post framed into it were found to be badly attacked; the tenon of the post had almost entirely vanished and the mortice in the beam so enlarged that my hand could be inserted and large quantities of powder extracted. Further, by striking the post sharply a continuous rain of worm powder poured down into the mortice cavity.

A similar case existed at point Y on the plan. The post was somewhat sounder, but the ceiling beam had a large cavity on one side, fortunately on the wall side of its bearing on the plate beam.

At point Z on the plan both beam end and post foot, though apparently without cavities, were tunnelled by the worm and gave a hollow sound. In these three positions a set of steel reinforcements were designed to stiffen the beam and to relieve the foot of the post from the load transmitted to it by upper beams and struts. The bolting up of the plates necessitated the through boring by hand of both beams and posts, an operation difficult and arduous in the extreme, yet most efficiently performed under conditions which many would have regarded as hopeless.

below the floor beam at point X on the plan. Fortunately, this is only a secondary or filler beam, but its end towards the wall plate had three quarters of the substance eaten right away and terminated in a jagged stump about one foot short of its original framed-up end.

At first it appeared there was nothing to prevent its falling, being in a most difficult position for complete examination, but it was eventually found to have been clumsily repaired in recent times, the efficacy of which I regarded with some doubt: accordingly this under beam has been strapped up to the new steel plates lining the sides of the floor beam over, by stirrups cleverly contrived and inserted by one of the workmen.

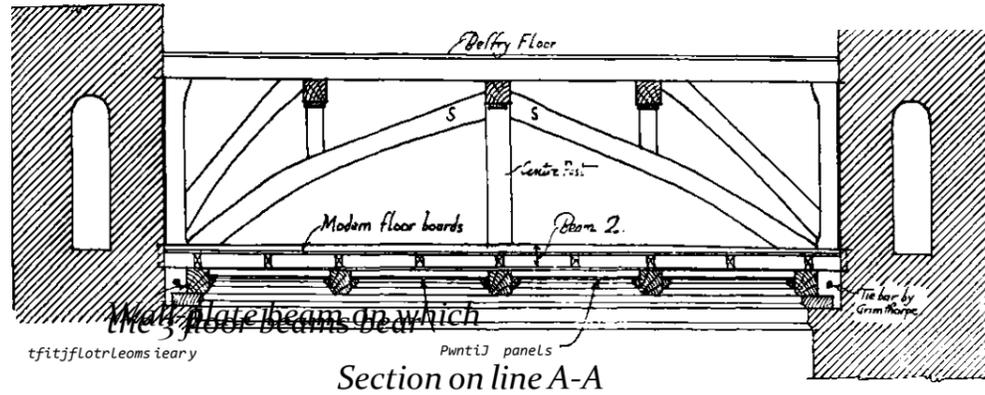
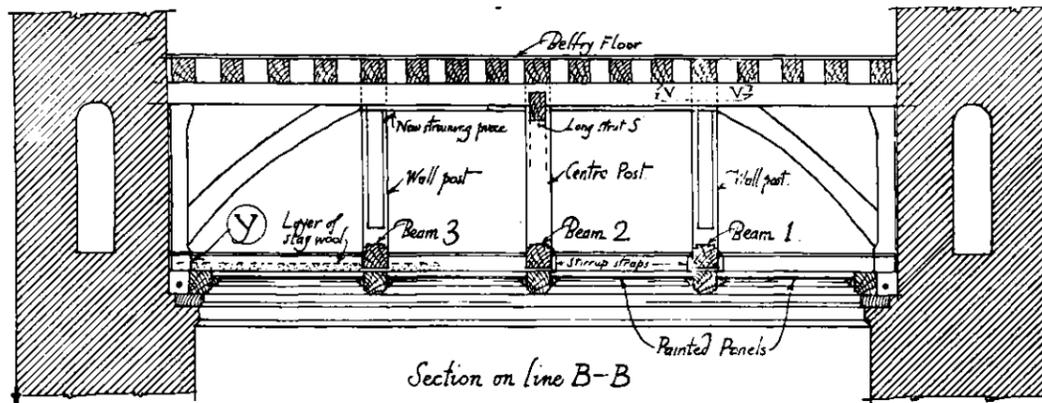
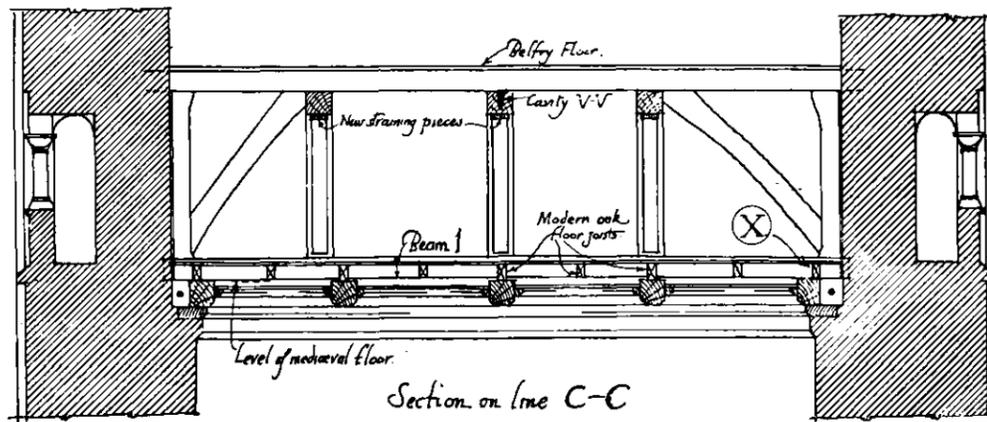
S^T ALBAN'S ABBEY CHURCH Section through belfry stage in Tower (see plan)

Among these upper beams, which number twenty and are set in two layers as shown on the sectional drawings, several badly worm-eaten and wet-rotted cases were examined, but in no case was it considered sufficiently serious to use steel plating. The deepest cavity occurs at the point marked V—V (see sections B—B and C—C) where the worm had eaten a long narrow chase down to the heart while leaving the flanks of the beam sound, borings having been made to test this. Fortunately the affected part lies immediately above a perfectly sound strut and a new oak straining piece. The half length of this beam alone consumed two gallons of solution. The six straining pieces, bolted to the under sides of the lower set of beams in the belfry floor, are of modern introduction and are very valuable stiffeners against rocking when the bells are rung. They were found to be of deal or pine and worm-eaten; consequently I have replaced them all with new nine inch by three inch oak well saturated with timber fluid. While these straining pieces were removed for treatment of the old beams, etc., temporary raking struts were inserted to preserve the requisite stiffness and allow the bells to be rung when required. Due

to natural shrinkage, etc., wedges were found inserted in all positions where beams cross and one rests upon the other. All were found more or less loose and badly wormed; consequently I have removed them and had new oak wedges inserted and tightly driven home after being well saturated with timber fluid.

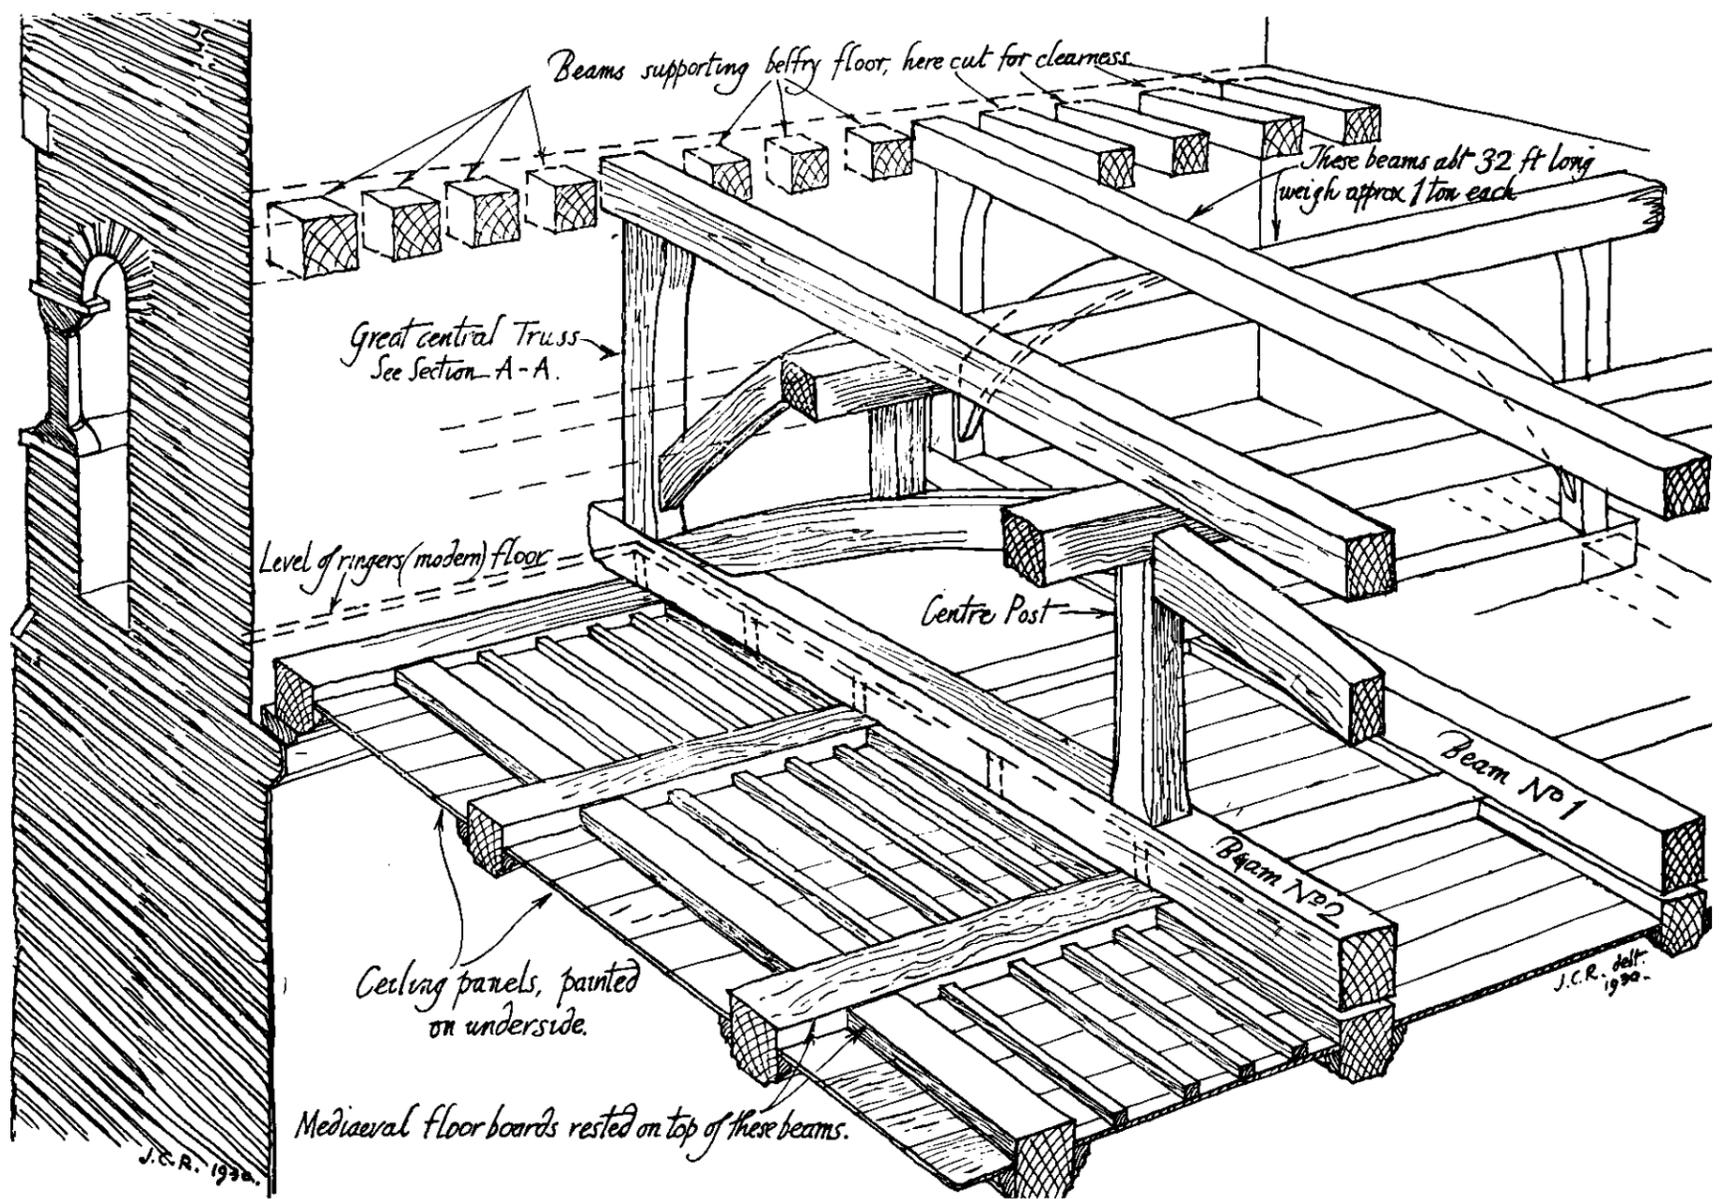
PLATE 3.
 ISOMETRIC SECTION SHOWING ARRANGEMENT OF TIMBER TRUSSES AND FLOOR BEAMS IN THE TOWER, ST. ALBANS ABBEY CHURCH

At this stage it was possible to make a careful examination of the main bearing and weight carrying beams, and it was at once clear that the three great floor beams numbered 1, 2 and 3 were practically independent of the under series of beams composing the frame of the panelled ceiling, except that in two or three places ancient iron straps united one beam to another.
