ST ALBANS & HERTFORDSHIRE
Architectural & Archaeological Society

The Renovation of the "Christopher Inn," French Row, St. Albans, 1950-54

A. S. MOODY, A.M.I.C.E., M.INST.M.E., A.M.T.P.I.
City Engineer and Surveyor

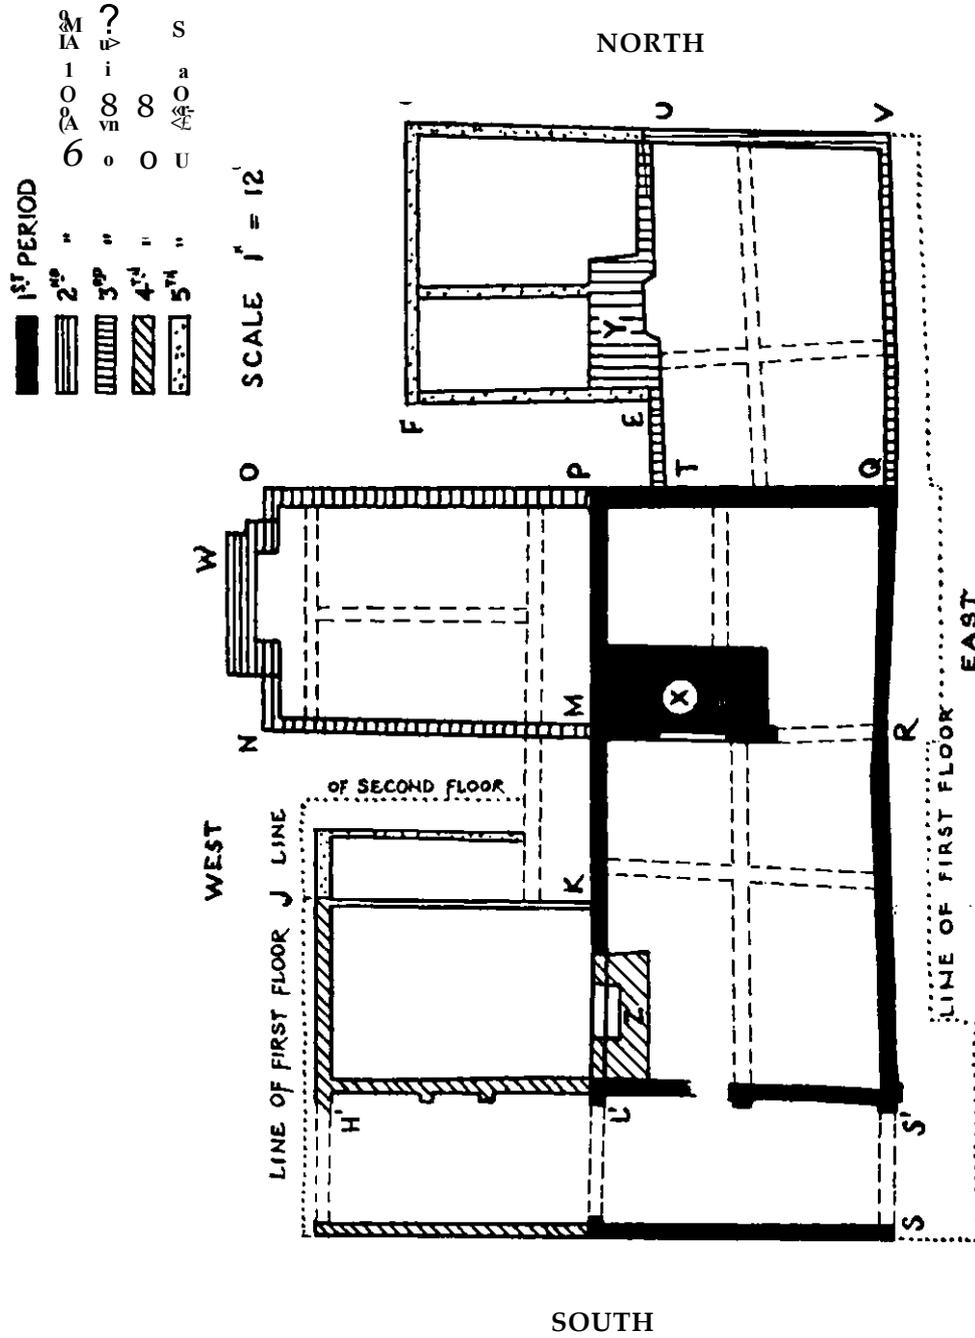
FIG. I

It was found that adjoining the archway on the south end the main post had sunk letting the whole front down; this was caused by the collapse of the cill into the cellar and the rotting of the foot of the post. The cill had also been cut through at a comparatively recent date so that a new doorway could be formed. The supporting cellar wall adjoining the roadway was also very poor.

A new brick wall was built in the cellar, the post shortened by about 2 ft. and the brickwork carried up

as a pier at this point. With great difficulty steel columns were taken up through the whole height of the building on both the front and centre line of the building. Steel frames were inserted to ensure the stability of the roof structure and many other steel joists were inserted at essential points as the need became apparent during the course of the works and defective timbers were found, and in fact, we had to "feel" our way through the building. These had the effect of taking the weight off the oak frame and eventually a state of structural stability was reached. The roof was retiled using the old tiles as far as possible with galvanised pegs in place of the oak pegs. Part of the rear roof was re-roofed with new matching tiles due to shortage of old tiles. Some of the rafters were replaced and others packed up and the tiles were laid on new battens and roofing felt. This had the effect of destroying to some degree the very wavy roof line but had to be done to make it watertight.

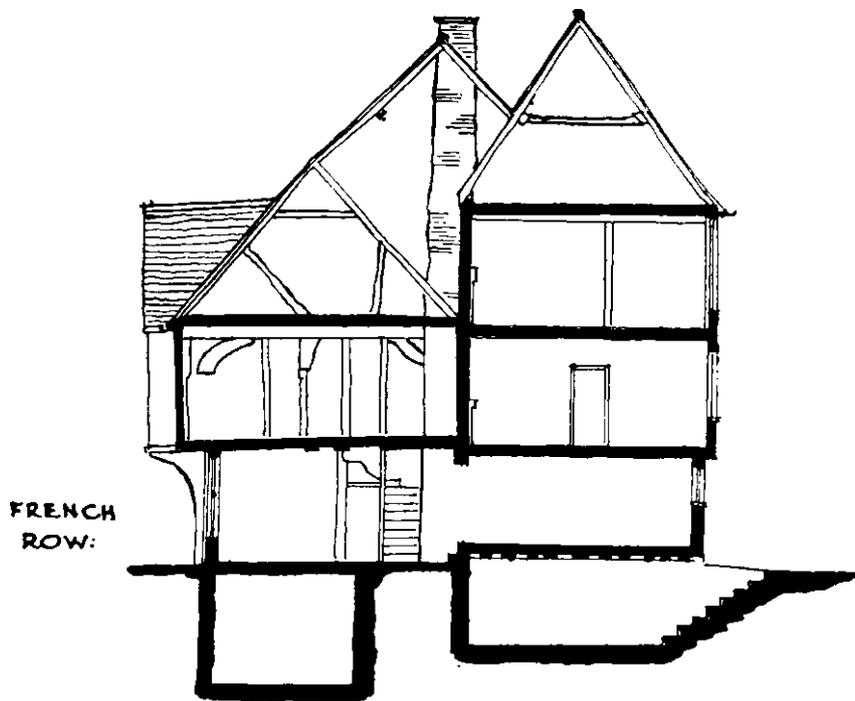
SECTION A.A.

The roof was of pairs of rafters of small scantling, with collars and no purlins. The struts from the tie-beams shown in the section A-A do not match, and it is probable that the one which is nearly vertical is a replacement, while that at right-angles to the rafter is original. I saw no trace of evidence for a king-post and collar-purlin. The roof of the south gable was of the same type, but that of the north gable has purlins.

On the first floor the partition between the room over the entry and the main room (shown in the section A-A) is substantially original, with a curved brace at each end: the partition on the line MR also has a curved brace at each end. The wall, LM, had evidence of one and perhaps two original doorways indicating that access to the first floor was from a gallery on the courtyard side, and indeed there was a beam in position which might have supported such a gallery. The chimney-stack, X, is probably an original feature, though perhaps enlarged when MNOP was added.

5. In the late seventeenth or early eighteenth century this wing was modernised, possibly owing to a failure of the roof. It was remodelled in the style of the period, and provided with a new roof, with hipped ends. This roof had A-shaped trusses, with purlins at the collar, as shown in the section A-A, and the cut-off rafters of the old roof were supported on its purlin. An additional attic floor was provided between the tie-beams and the collars. This floor apparently was
