## St. Albans Abbey: Excavations on the site of the Great Cloister and adjacent buildings, 1924.

BY ERNEST WOOLLEY, F.S.A.

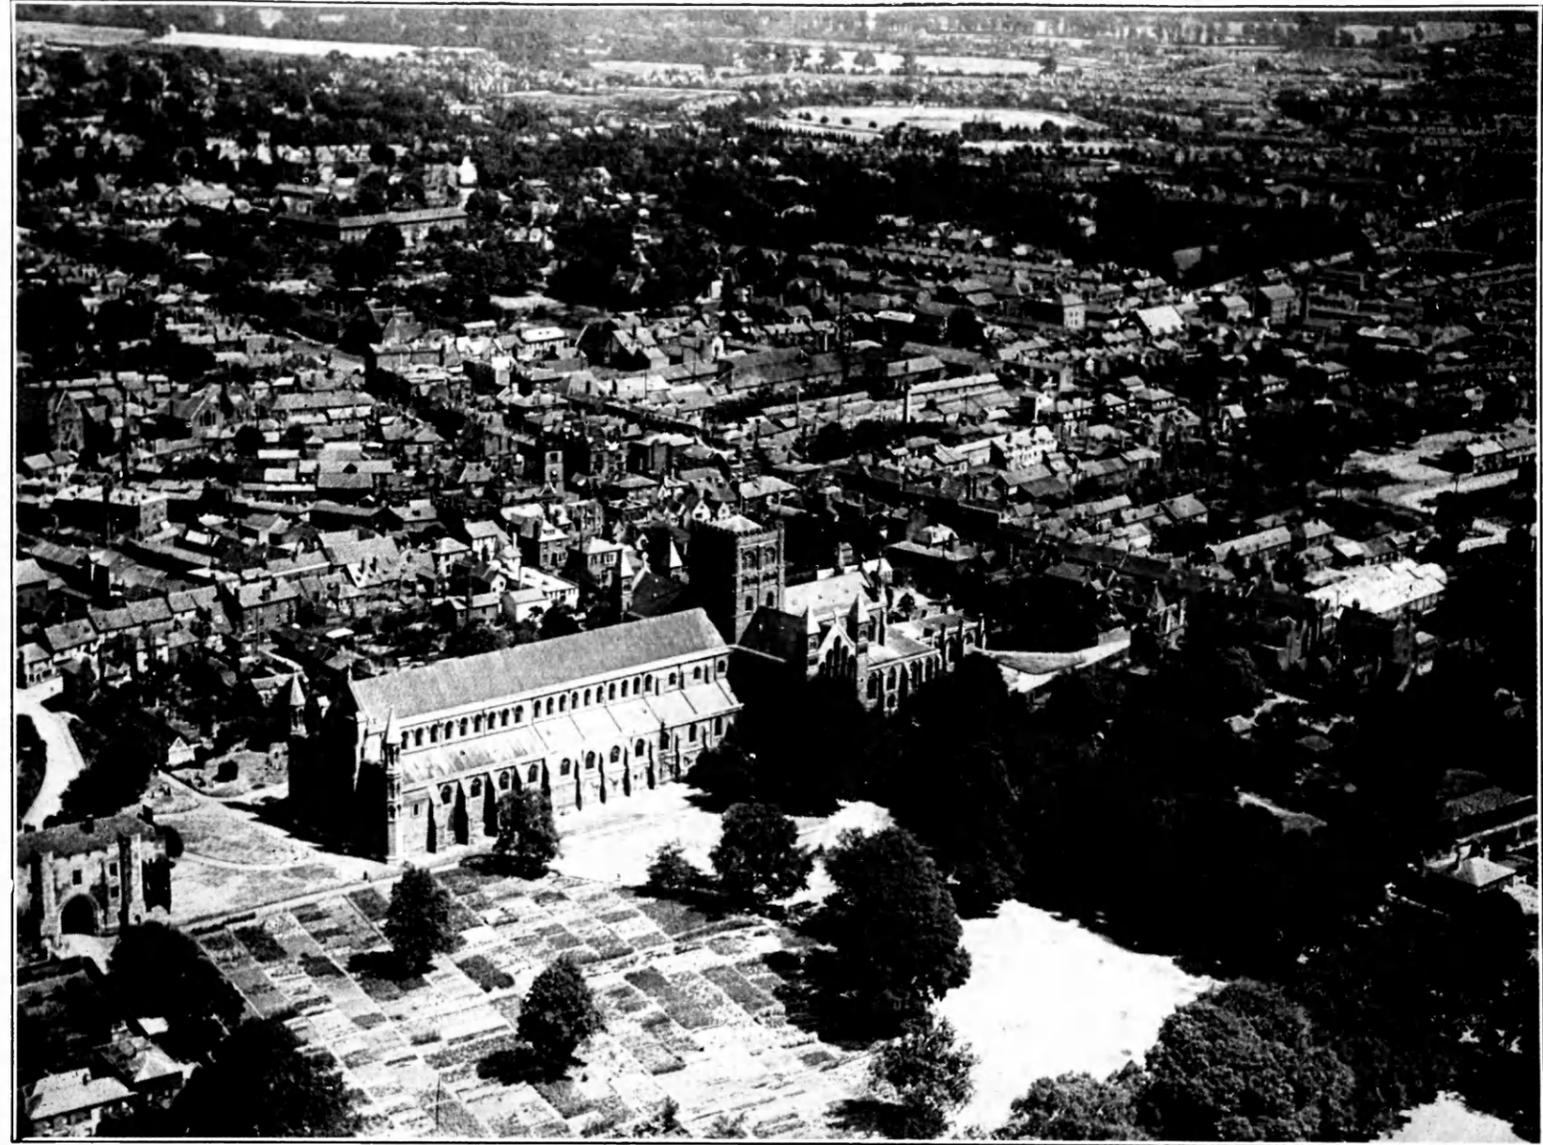
AERIAL PHOTOGRAPH SHEWING SITE OF ST ALBANS ABBEY EXCAVATIONS 1924

This aerial view of part of the City shows very well the scene of the excavations south of the footpath which runs along—a short distance from—the south side of the Church.

The site of those excavations is just westwards of the south transept, the west wall of that transept having formed part of the eastern cloister walk.

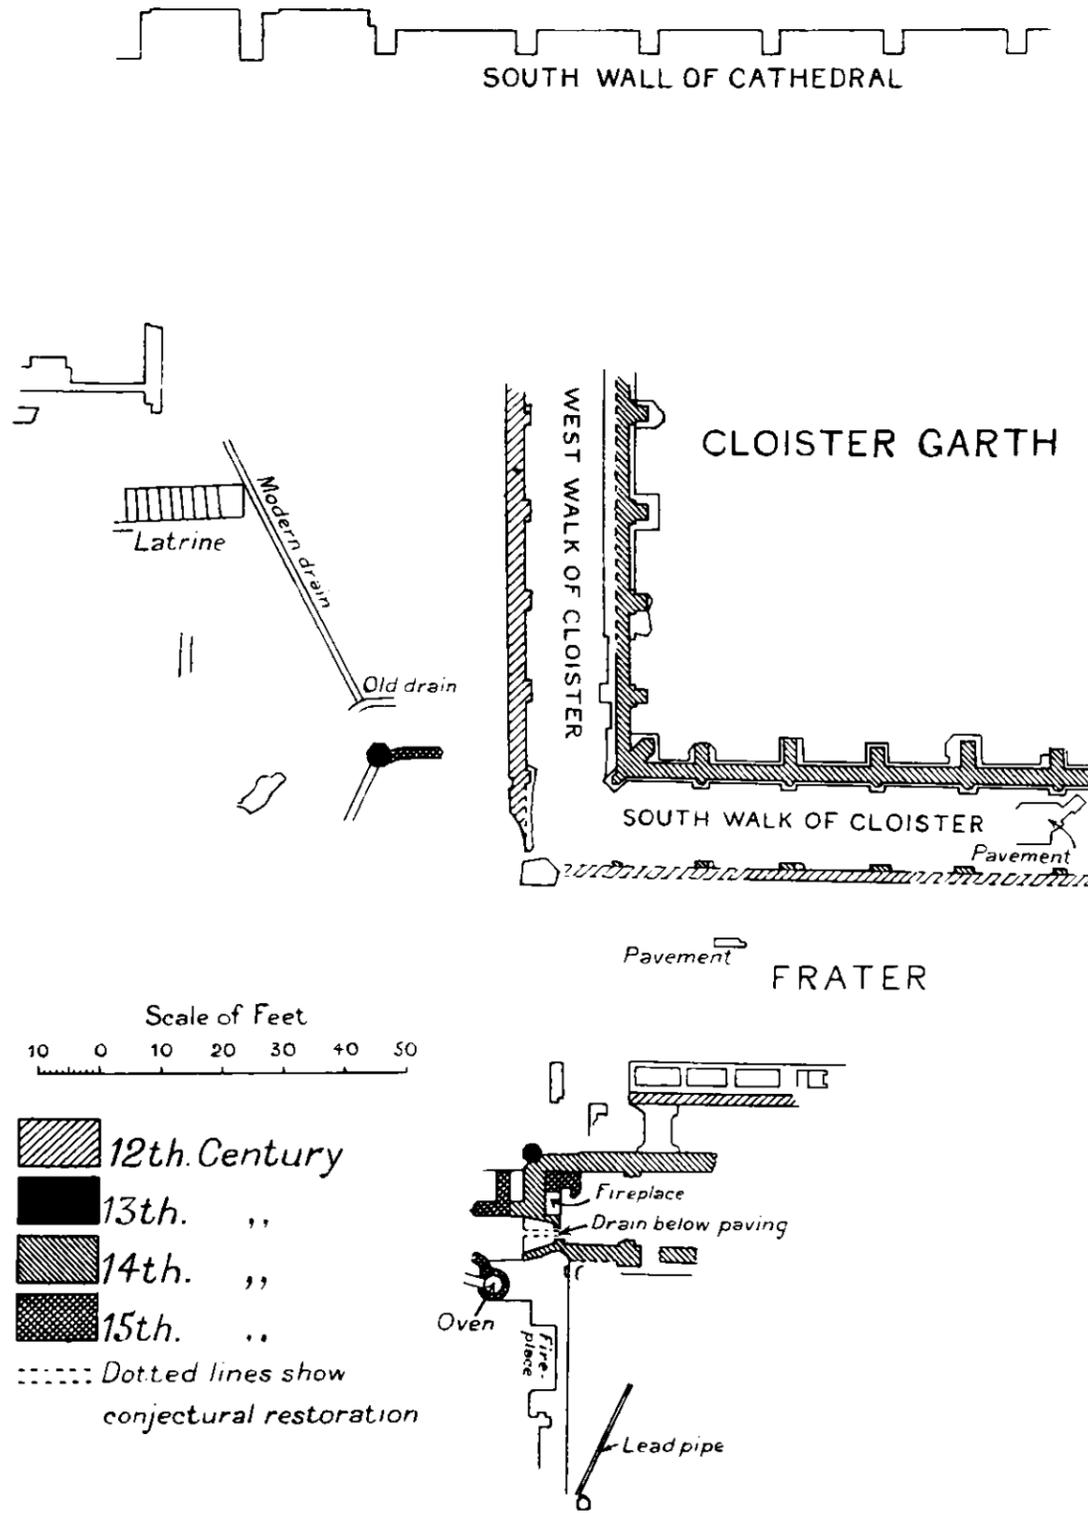
PLAN OF ST. ALBANS ABBEY EXCAVATIONS 1924

Taken by permission of the Parochial Church Council from a plan kept in the Abbey Institute which was made by Mr. E. R. A. Rahbula, F.S.A., of the office of the Royal Commission on Historical Monuments.

The Church is referred to in the plan where at the top the line of the "South wall of Cathedral" is shown.

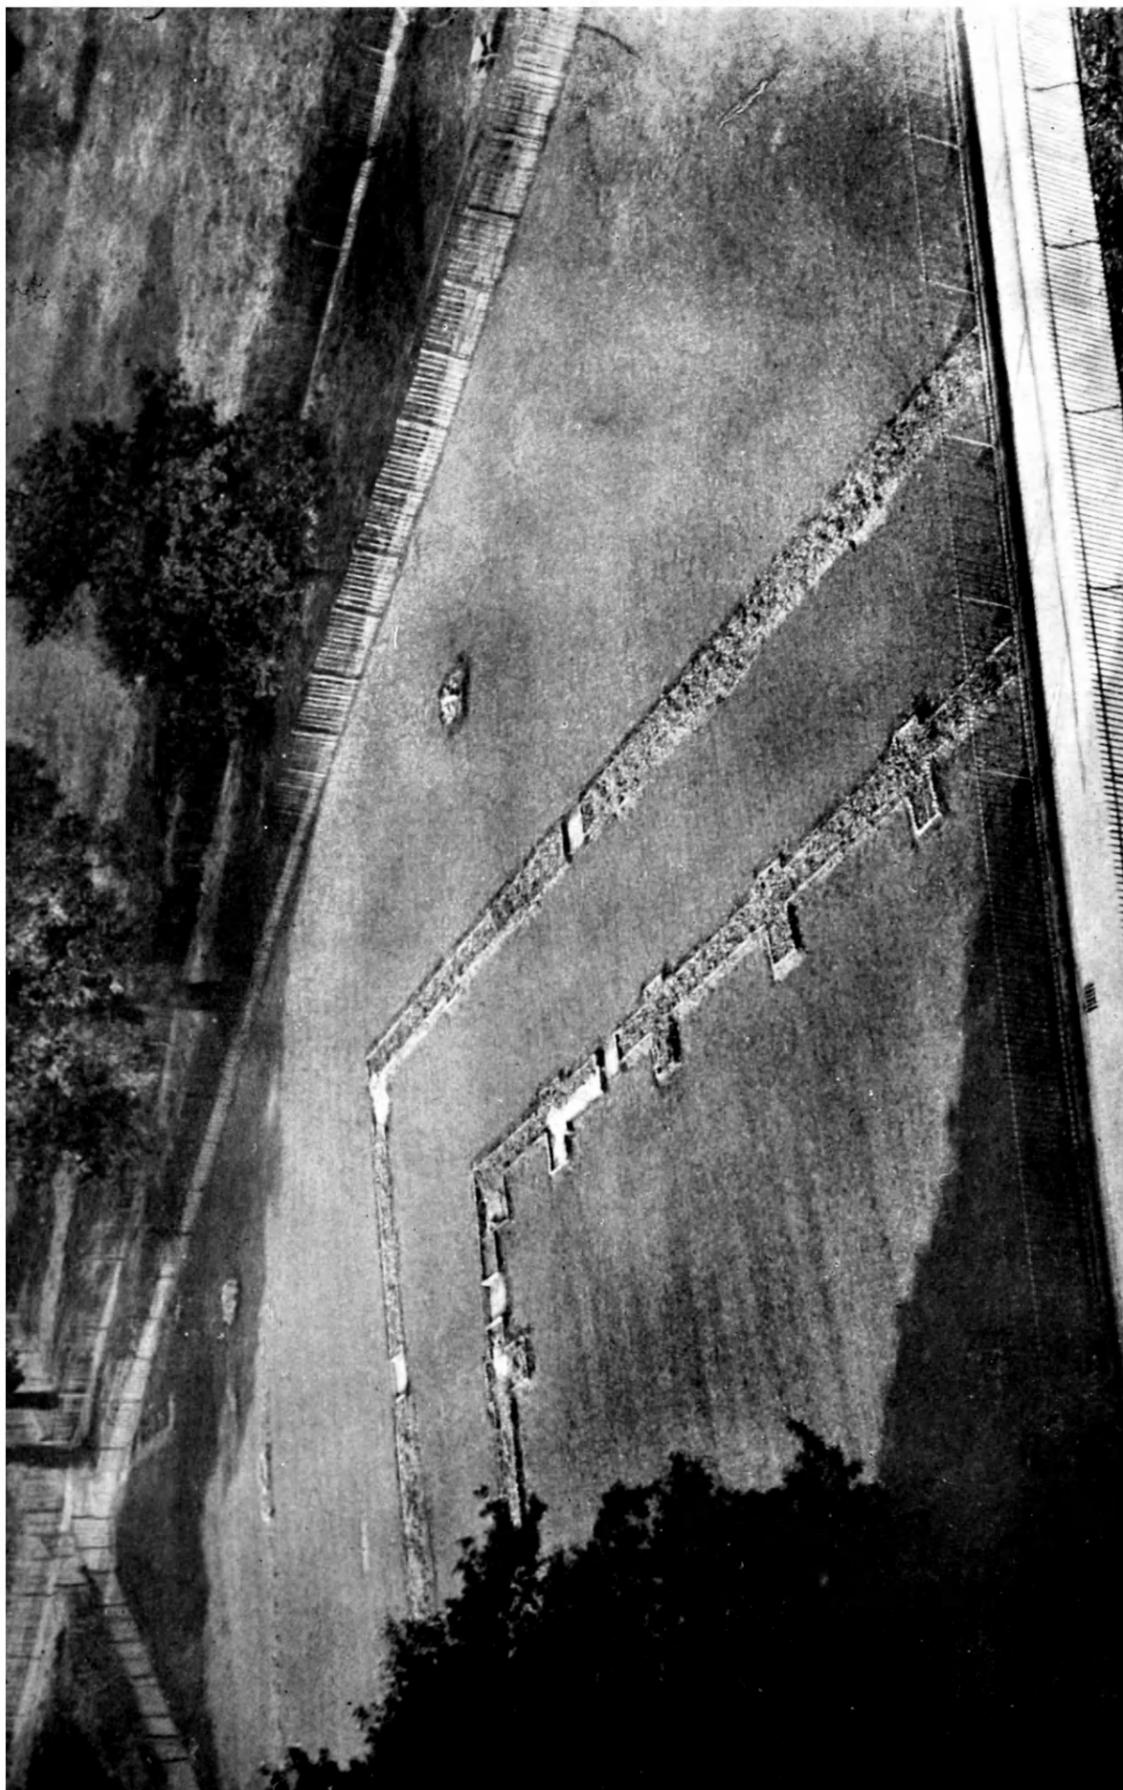
SITE OF ST. ALBANS ABBEY EXCAVATIONS 1924  
Taken 3rd October 1925

Taken from a scaffold, when the parapet of the Church was being repaired, on 3rd October, 1925, looking down on the site and showing the excavations now filled in, except the line of the lead pipe, Plate IV. They are, however, marked out, the cloister walk by garden-path tiles planted with periwinkle in between, the other items by stones.

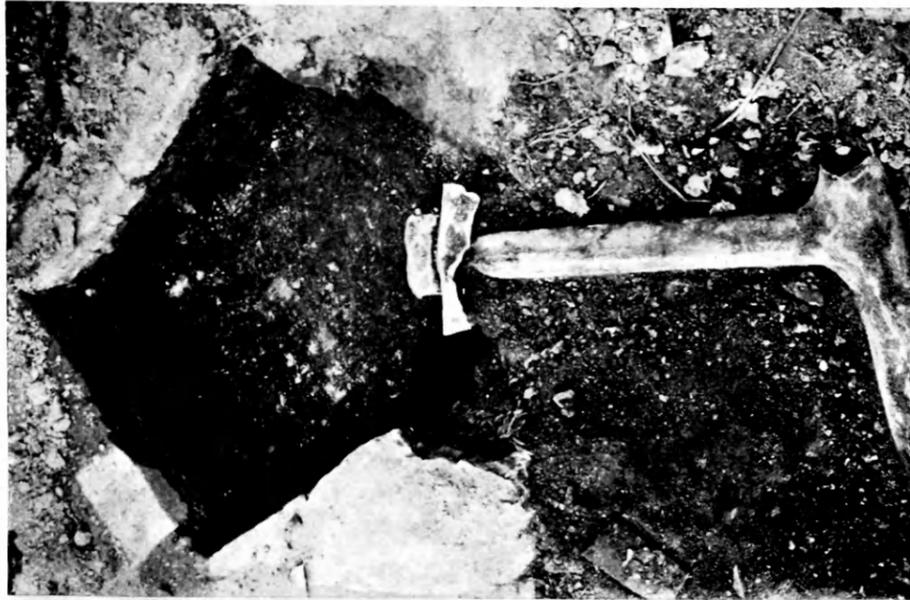
2

**Fig. 2.** Is at the turn, see under Fig. 1, this piece of pipe ending over a sump which is at the extreme end of the site excavated, where in Plate III the two fences meet at the top near the left-hand side but on the plan. Plate II, at the bottom, the points of the compass in the prints being reversed.

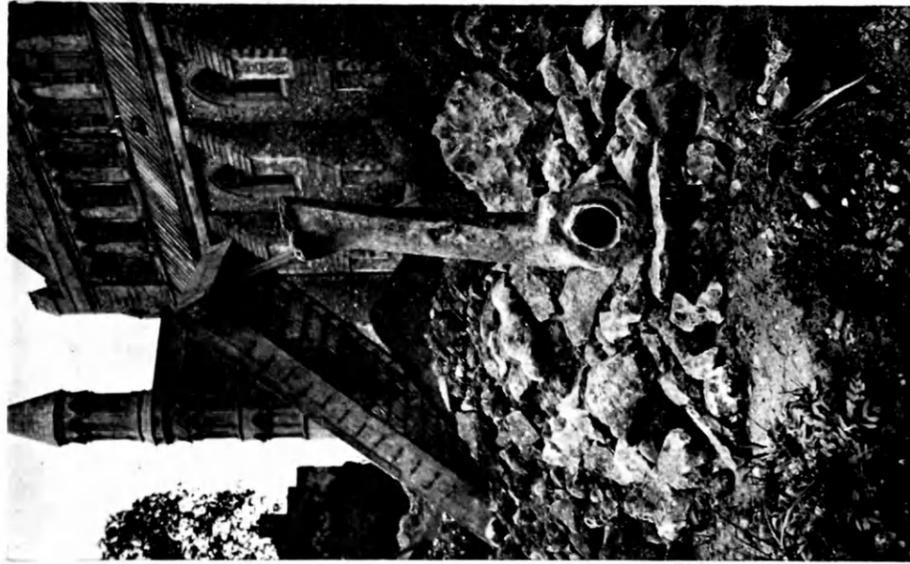
**Fig. 3.** Is an L shaped stand-pipe, probably to supply the kitchen, showing the collar at the joint  $\frac{1}{2}$  inch away from the point where it was broken off from the main pipe, Fig. 2.

The bottom length is  $7\frac{1}{2}$  inches and the upright 1 foot 6 inches, the inside diameter being 3 inches.

I may say that the sieve behind the pipe, appearing to support it, has no connection with it but was some distance away. This piece of pipe was removed for safe keeping to a shed nearby, and was set up by me on a heap of stones to be photographed. It is at present at the Hertfordshire County Museum, St. Albans. The sieve was for screening the excavated soil, partly lest any small objects should be missed.

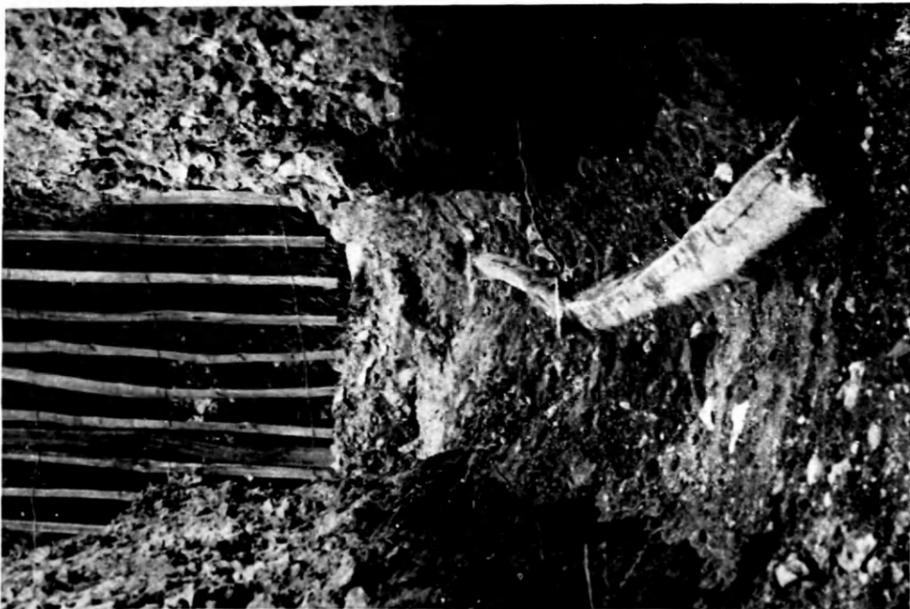
**Fig. 1.** Is a length of lead water-pipe, 19 feet 11 inches long, with two joints, one at 6 feet from the front end in the photograph and the second at 16 feet 1 inch. At the other end a turn to the left of 1 foot 7½ inches. Fig. 2, where it is jointed at the end into a collar of lead, 2 inches thick by 4 square, with orifice 2¼ inches the same diameter as that of the inside of the pipe.

The pipe is made of sheet lead about  $\frac{1}{8}$  thick, made up in section approximately to the shape of a pear, and the edges turned straight up, at what would correspond to the stalk end of the pear, and beaten together.

Along each length to be joined together a continuous line of clay was then attached to the pipe and formed into a gutter on either side of the turned up edges about  $\frac{3}{4}$  inch below the top.

Molten lead was then poured along to within 1½ inches on either side of the joint, the longitudinal flow of the lead being stopped there by clay dams round the pipes.

Then the two dams had a clay cover formed across them clear of the pipes, and molten lead was poured into the cavity which set round the pipes and made a collar over the joint with a top, beaten flat, 3 inches across the pipe, now made into one, and 2¼ wide, rounded off at the corners, and protruding  $\frac{1}{4}$  inch from the pipe, as seen in Fig. 1.

It will be observed that the molten lead along the top of the edges has set in the form of a ridge like an inverted V.

The length included in Figs. 1 and 2 is now deposited in the north Presbytery aisle of the Church.

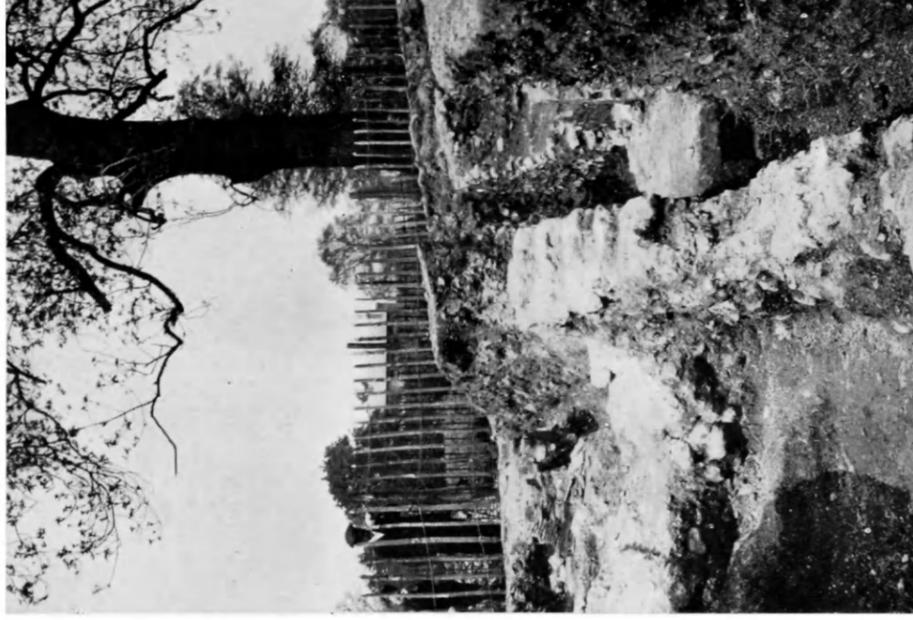
3  
Drain below paving

**Fig. 3.** Fifteenth-century drain, marked on plan Plate II as below paving, and north of oven in Fig. 2.

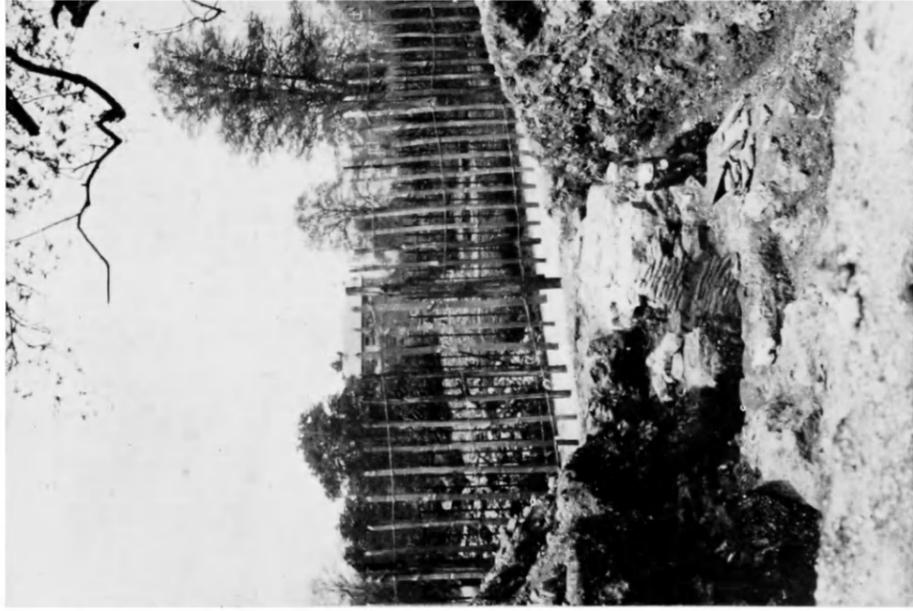
2  
Oven

**Fig. 2.** One of two fifteenth-century ovens north of and slightly west of the fireplace in Fig. 1.

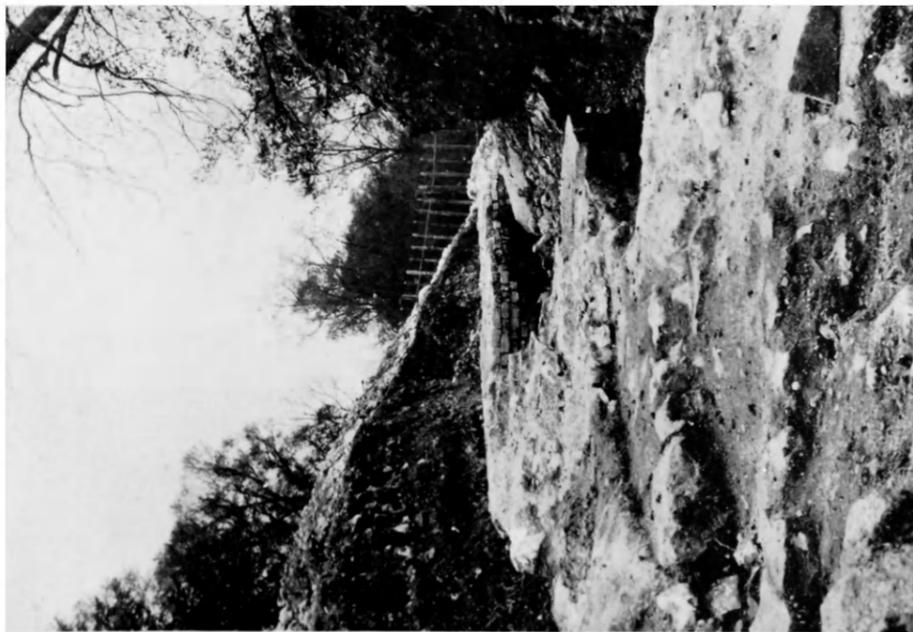
1  
Fire-place

**Fig. 1.** A fireplace, probably that of the great kitchen, marked on plan, Plate II, a little to the left, and north of the lead pipe.

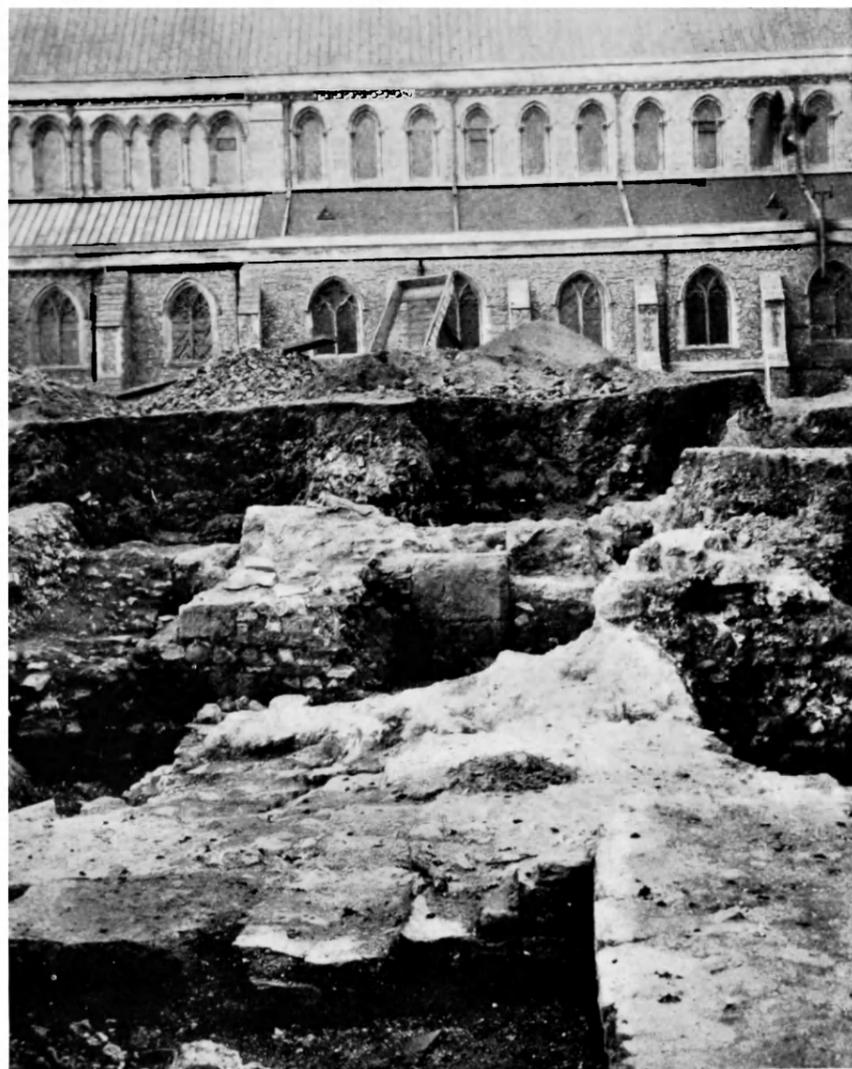
1  
Looking North

**Fig. 1.** A series of walls and blocks of masonry north and eastwards of Fig. 3 in Plate V, looking northwards towards the south side of the Church.

Both these appear to be of the fourteenth century, as indicated in the plan south of the Frater.

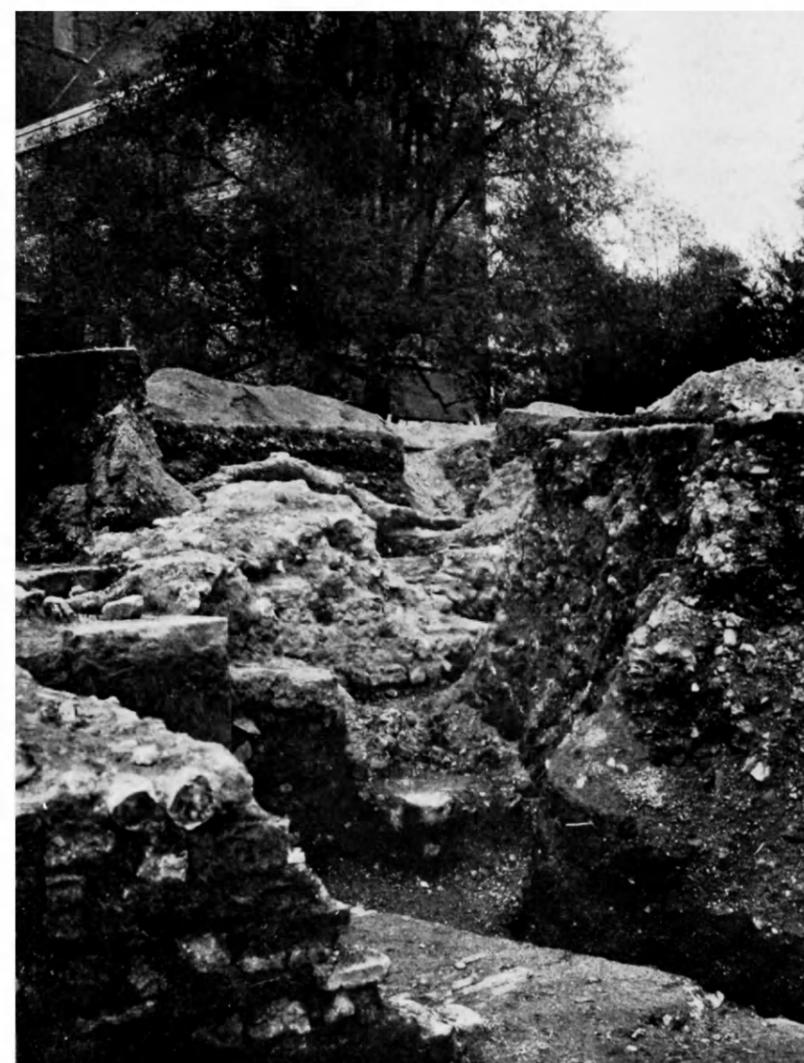
2  
Looking N.E. towards South Transept

**Fig. 2.** A similar series of walls and blocks of masonry from the eastern middle of Fig. 1, looking north-east towards the south transept south-west corner.

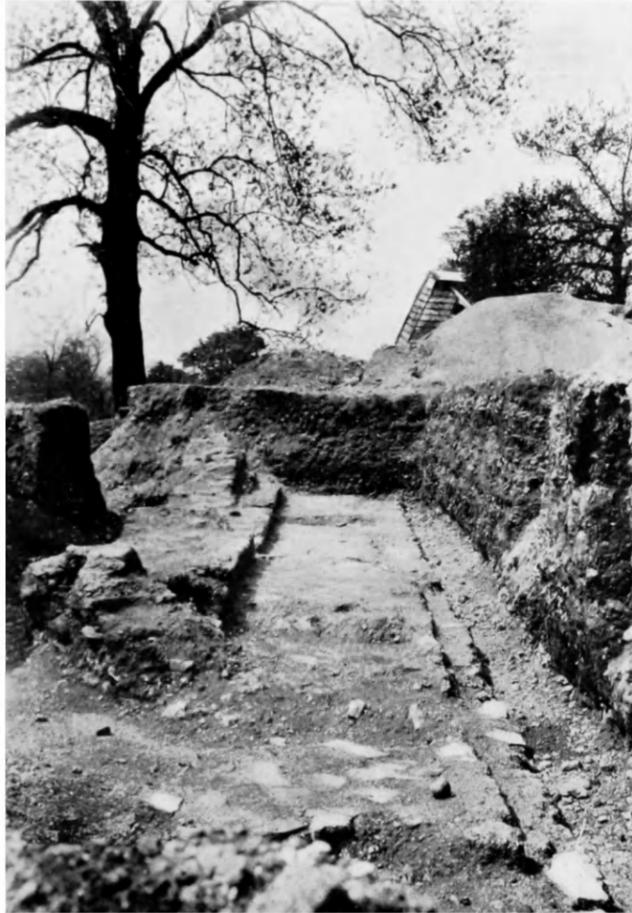
1  
Frater

**Fig. 1.** This is clearly the Frater of the twelfth century, with some floor tiles *in situ*.

“The great Frater stood, as usual, on the south side of the cloister and is the most remarkable building of which remains were found during the excavations.

“Only small portions of the north wall had survived, but a much larger portion of the base of the south wall.

“This south wall was of a most unusual character, and consisted of an outer portion or skin of masonry (1 foot 9 inches thick) which was evidently carried right up the building and an internal offset (5 feet wide) finished with a level top surface  $2\frac{1}{2}$  feet below the later floor-level.

“The top surface of this offset or shelf retained the matrices of a horizontal framework of timber consisting of a plate laid along the outer edge, a second plate laid against the skin-wall and a series of connecting timbers spaced about 8 feet apart.

“That a corresponding arrangement formerly existed on the north side of the Frater also, is indicated by the thinness of the surviving pieces of the outer wall, which corresponds to the skin-wall on the south side.

“There can, I consider, be only one explanation of the facts as they stand, and that is that the Frater at St. Albans was essentially a timber building with merely an outer skin of masonry.

“The horizontal timber-framing, of which the imprint remains, must have supported a double row of posts, the outer standing on the plate against the skin-wall and the inner row standing on the second plate.

“The logical outcome of this double row of posts is the carrying of a cantilever-beam, such as a hammer-beam of the main roof-truss, the employment of which in a timber building would demand some such arrangement if the requisite rigidity was to be obtained.”

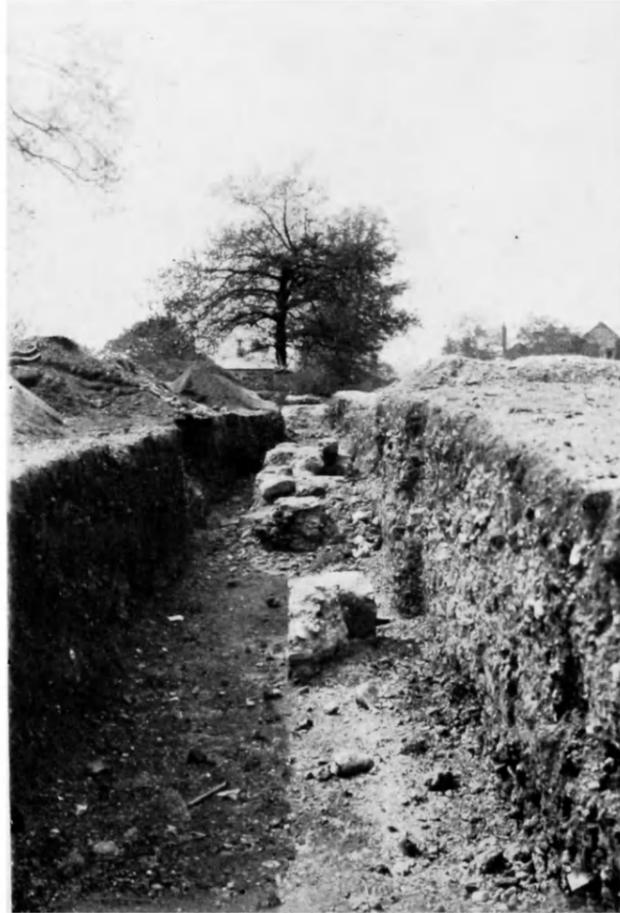
2  
South wall South Cloister walk

**Fig. 2.** All that is left of this part of the south wall of the south cloister walk, twelfth century.

The walk, Figs. 1 and 2, continued up to the Church and then turned along the side of the south wall and the west side of the south transept and southwards to join the south walk, Plate VII Figs. 2 and 3, completing the square enclosing the garth.

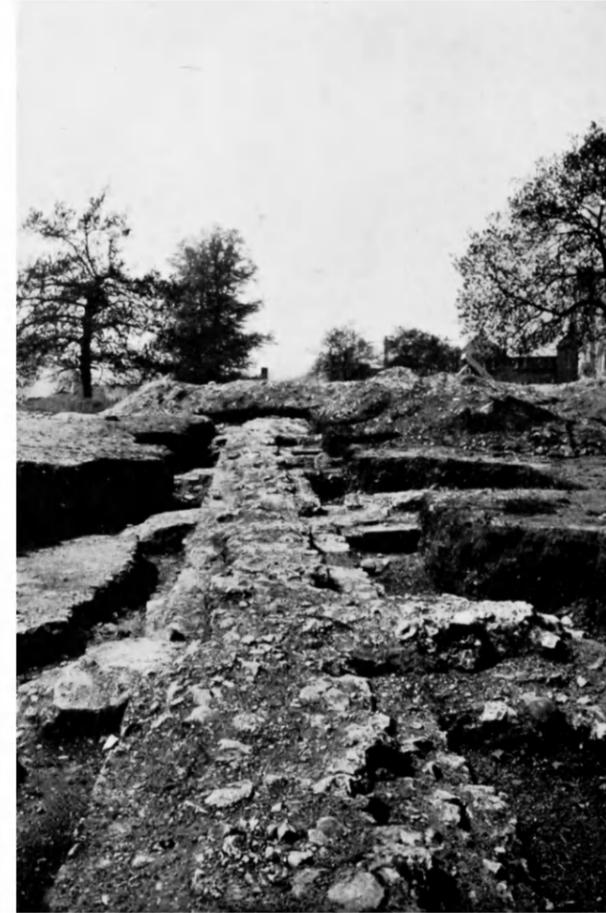
3  
North wall North Cloister walk

**Fig. 3.** The north wall of the south cloister walk which is of the fourteenth century, having evidently been rebuilt on the twelfth century foundations, in part, to correspond with the new north cloister walk after the fall of that portion of the nave arcade and south aisle which fell down in October, 1323, and destroyed the old north cloister walk.

The destruction of this part, which abutted on the south wall of the Church, after the dissolution of the Monastery so weakened the wall that buttresses were, some years ago, built to strengthen it.

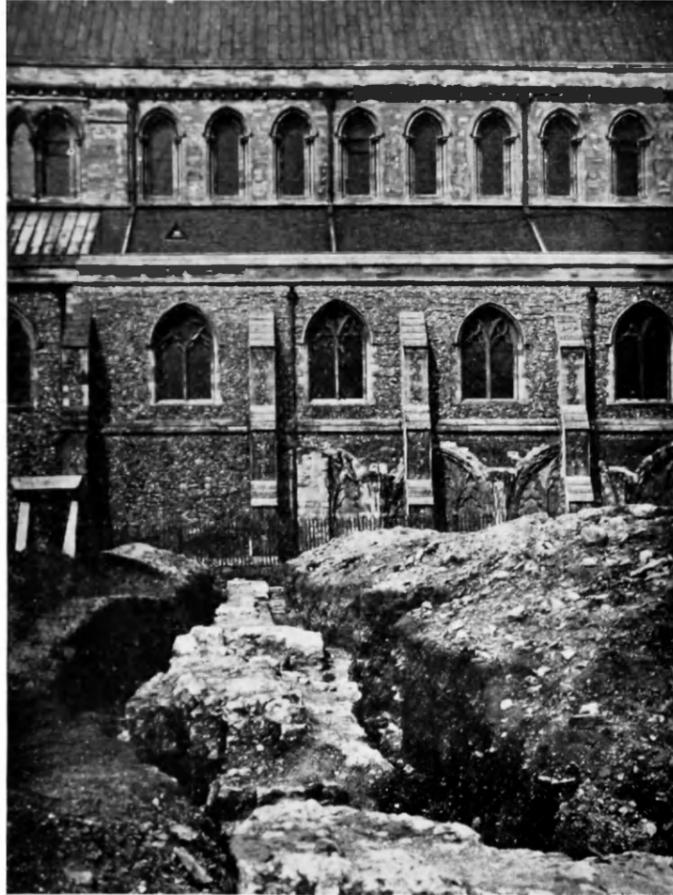
2  
West Cloister walk West wall

**Fig. 2.** The west wall of the west cloister walk of the twelfth century.

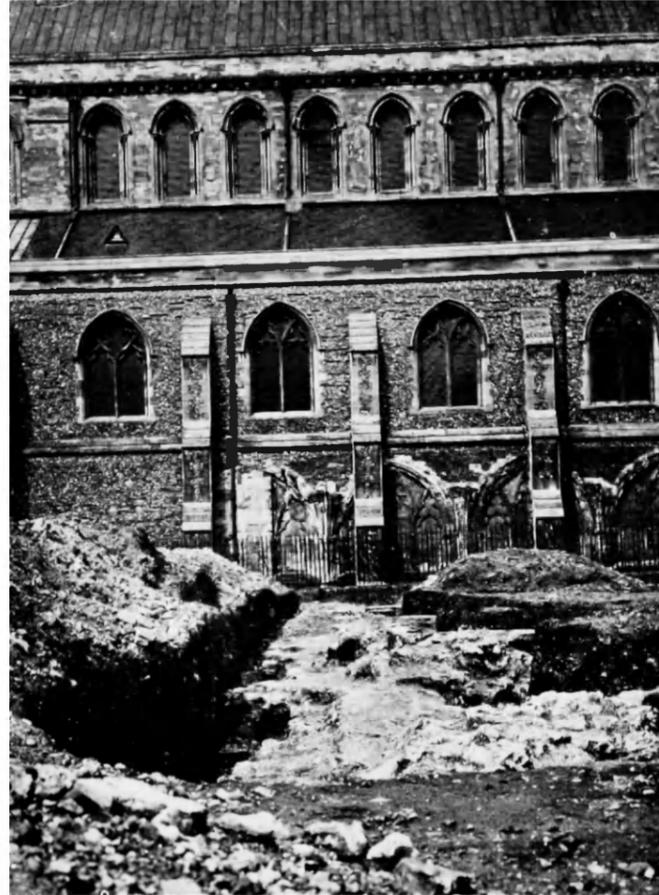
1  
West Cloister walk East wall

**Fig. 1.** The east wall of the west cloister walk, also fourteenth century, having been similarly rebuilt.

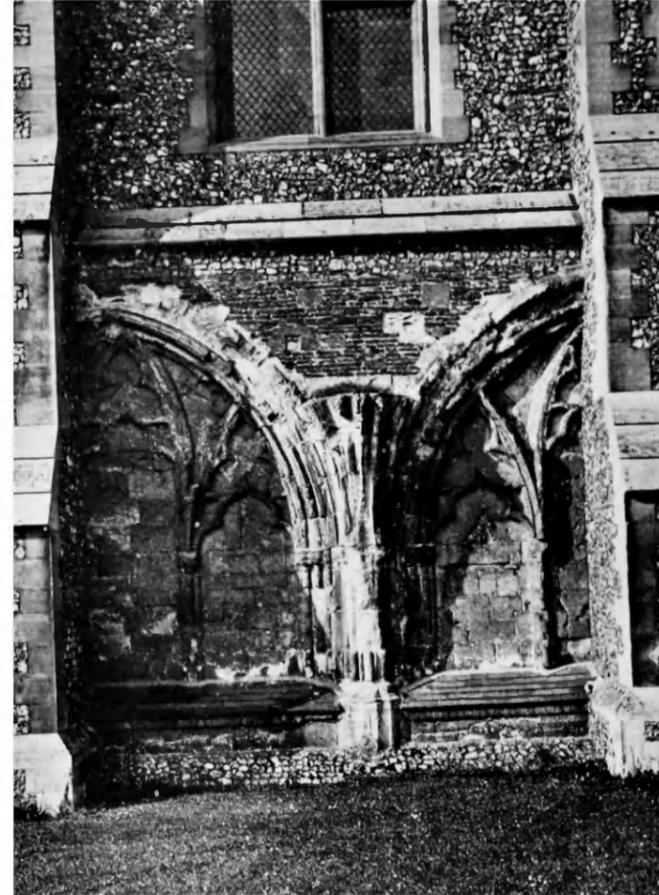
3  
North Cloister walk North wall arcade

**Fig. 3.** Detail of wall arcading of north cloister walk still existing but now on the outside of the south wall of the Church.

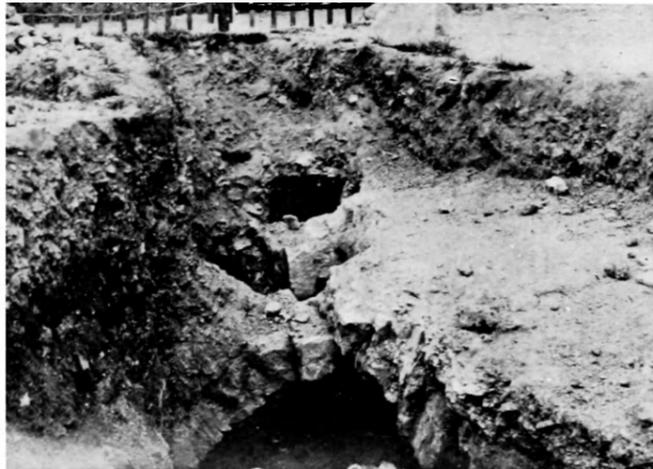
1. The two top Arches

**Fig 1.** A latrine marked on the plan, Plate II, and just distinguishable in Plate III half-way up on the extreme right edge.

It is a deep pit 18 feet 8 inches long by 5 feet 3 inches wide, the walls all flint 15 inches thick and the depth below the floor of the cloister 26 feet.

It was surmounted by four arches at intervals. Three

of these were found but one fell in, and this photograph shows the two which were left.

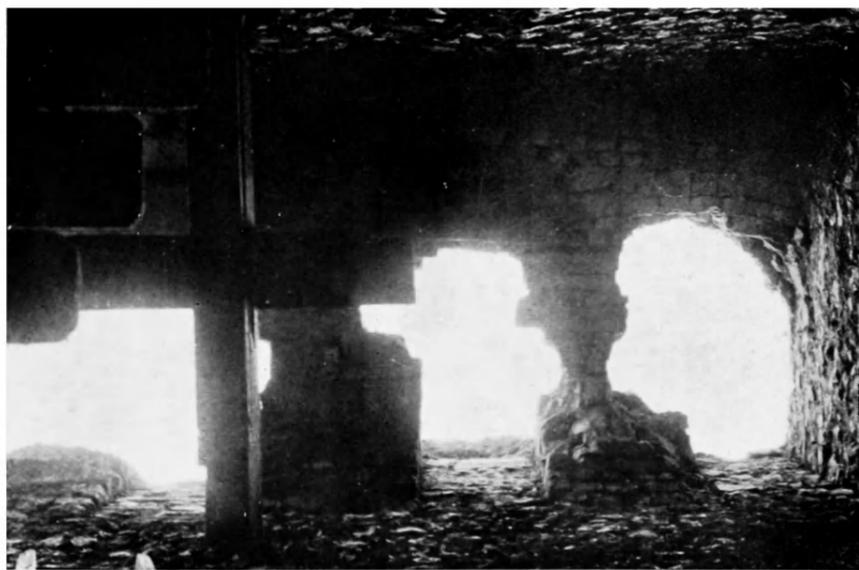
3. The above Arches from the floor

**Fig. 3.** In the centre are the above-mentioned two arches and indications of the spring of the third on the left, taken from the floor looking up skywards.

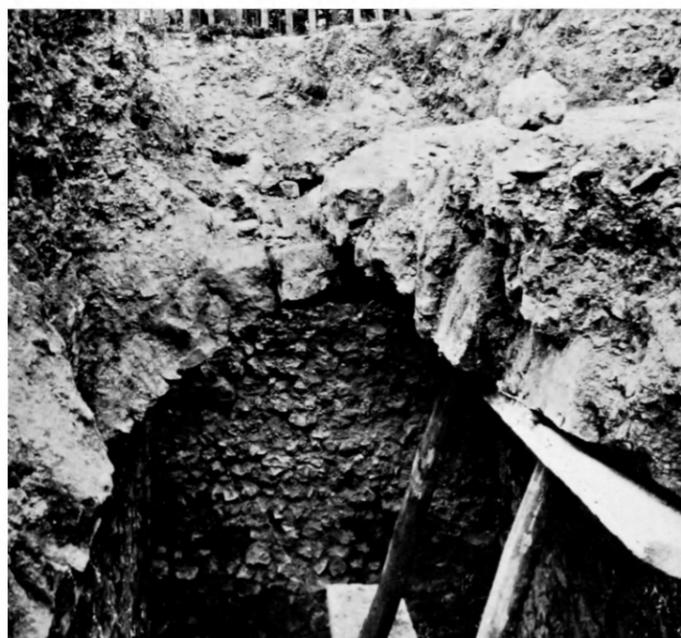
2. The front Arch and West wall  
LATRINE

**Fig. 2.** A larger picture of the eastern of the two arches showing its construction, but shored up with planks lest it also should fall in.

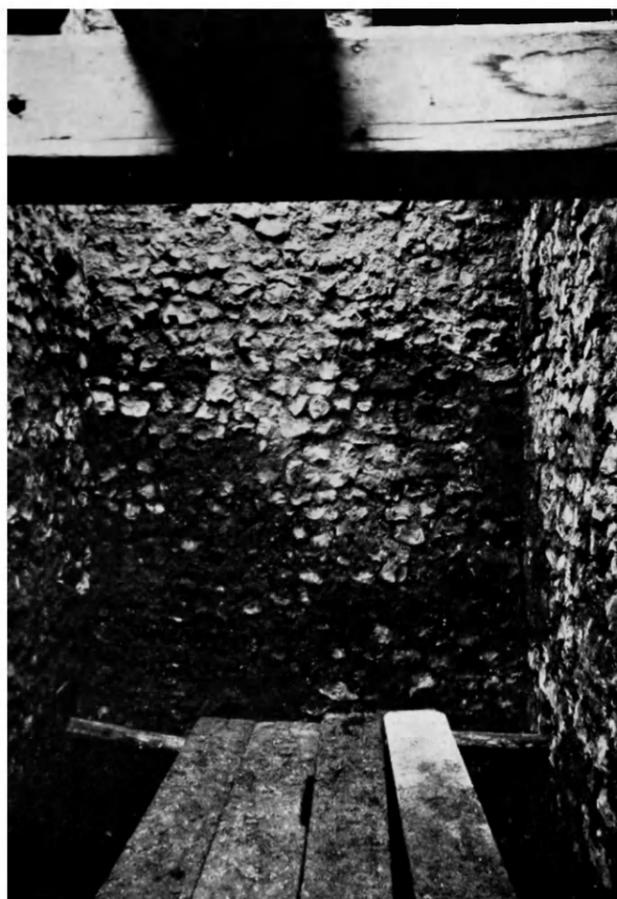
1  
West with pudlock holes in sides  
Latrine

**Fig. 1.** Latrine west wall of flint.

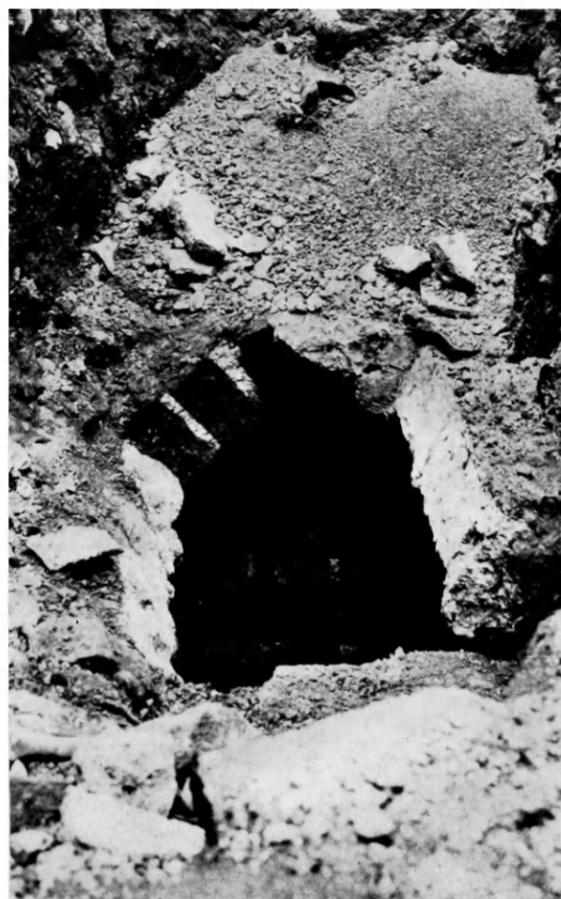
3  
End of modern drain discharging  
into medieval drain

**Fig. 3.** In the centre is the end of a modern drain, where it discharged into a mediæval drain running at a lower level, which is marked on plan Plate II as "old drain," west of the cloister walk.

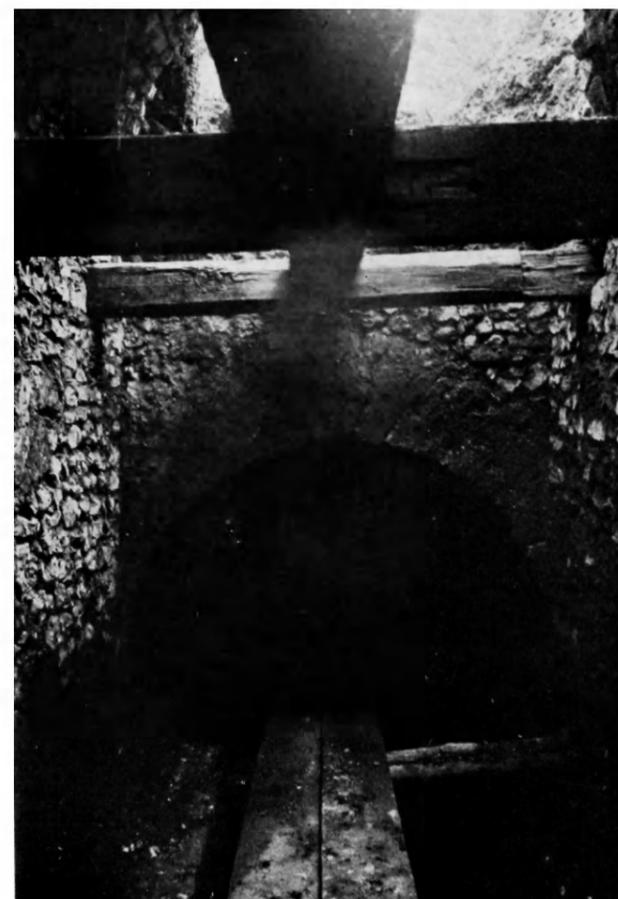
2  
Eastward Retaining Arch  
Latrine

**Fig. 2.** An eastward retaining arch put in to keep the side walls from falling in. In the top left-hand corner the turn of the arch over the whole is visible.

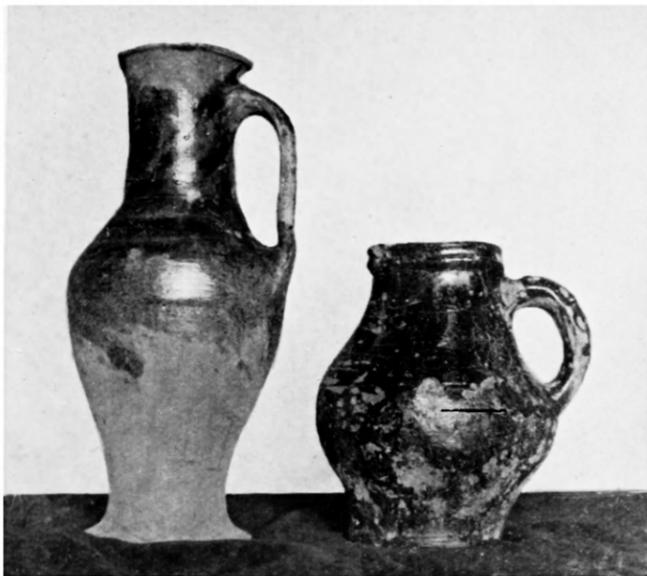
2

**Fig. 2.** Makes a charming group and each item is very interesting. The cooking pot or pipkin; height to the top of the cover knob  $5\frac{1}{8}$  inches, girth 18, handle  $3\frac{5}{8}$  long.

The centre jug strikes me as singularly graceful and is of a beautiful grey hue; height  $10\frac{3}{4}$  inches, girth 20.

The jug on the right is nicely ornamented; height  $7\frac{1}{4}$  inches, girth  $16\frac{7}{8}$ , brown glazed.

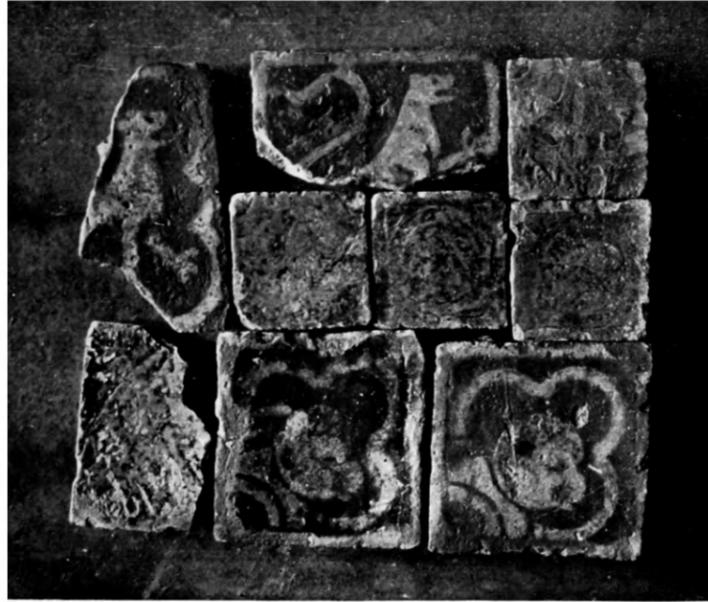
2  
Tiles

**Fig. 2.** A small group of medieval heraldic and rebus tiles, the latter monkeys' heads.

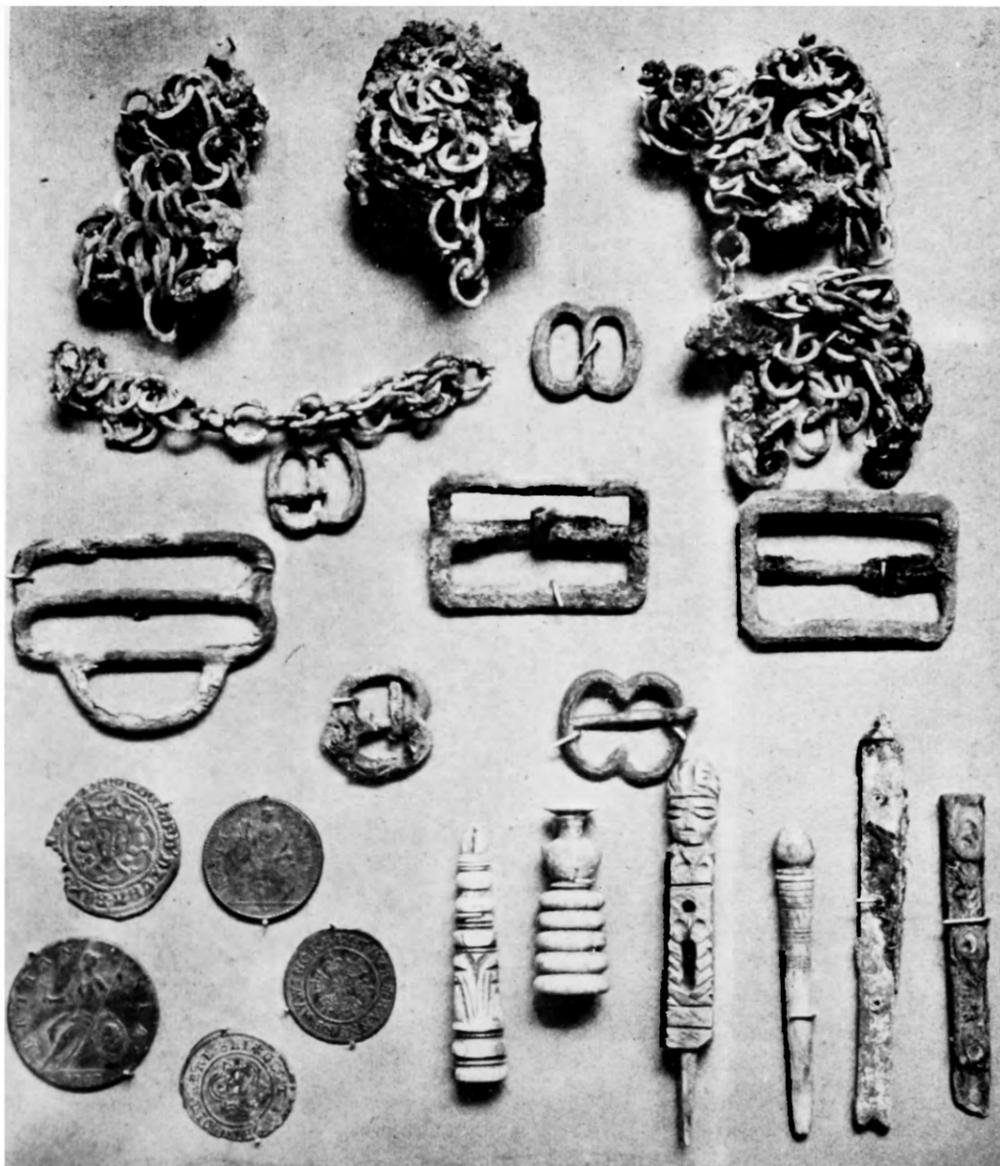
I  
Chain Armour, Buckles, Slide, Coins, Tokens, Chessmen, Reliquary Corner  
piece, Engraver's Etching Needleholder, Knife handle, its horn Cover

Next is a bone handle for an etcher's needle and at the end of it is the lump of the oxidised needle.

The two pieces on the right belong to each other. That on the left is the iron handle of a knife and on the right, exactly fitting it, is the horn covering. The cover is easily mistaken for wood but the long grain of it is clearly that of horn.
