Excavations at Verulamium

INSULA XVII, 1938

By K. M. RICHARDSON, B.A.

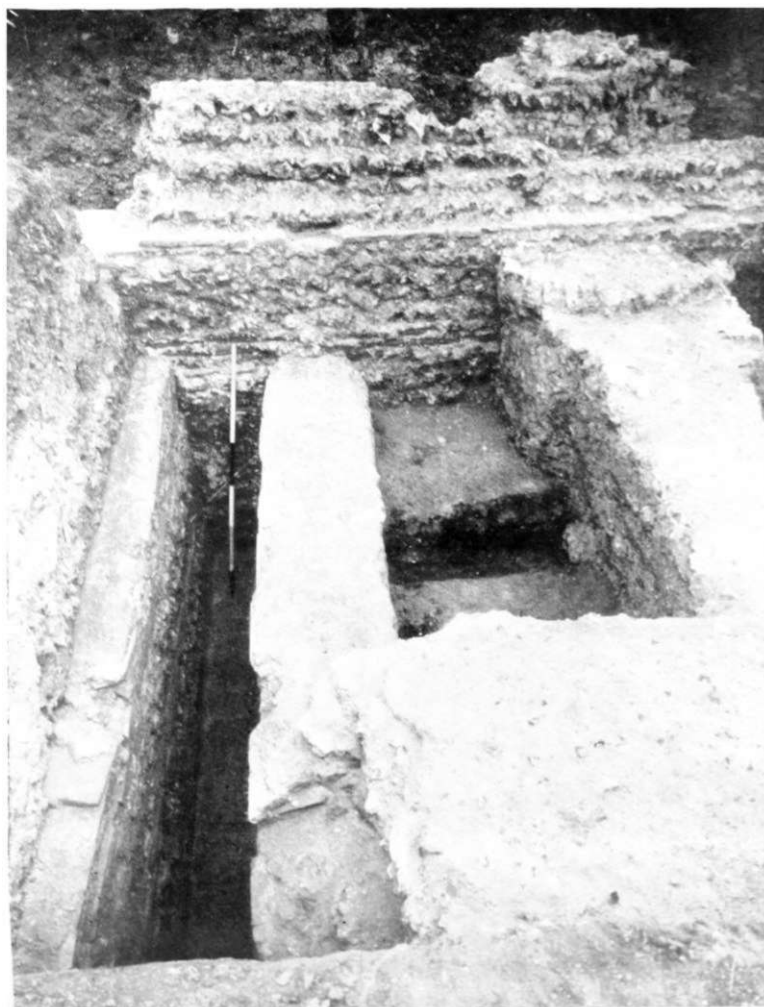
FIG. 2. PHASE III CONDUIT BLOCKED BY PHASE IV
W ALL PHASE V BUTRESS ON RIGHT.

The only other feature of Phase III was a water channel, 5 feet 6 inches deep, built in alternate tile and flint courses with a tiled floor (Figs. 2 and 3). It had been wrecked and robbed in the eastern half of the building, where its approach to the house could not be traced, but it ran straight through the western end and disappeared under the present road. Curiously enough, its floor was found to drop a foot in 50 feet, going from east to west, that is uphill and away from the river, so that it must have been in the nature of a conduit rather than a drain. A trench dug on the theatre side of Watling Street failed to show its continuation, at any rate in a straight line.

layer of clay and rubbish. The western half was also pulled down, but the footings were re-used in the erection of a second building, the main walls of which conformed fairly accurately with the underlying masonry. A new outer east wall was built and this and the rebuild of the main west wall blocked the water channel and put it out of commission as a conduit (Fig. 2). Inside the building the surviving small rooms apparently continued in use. The main addition was an apse placed centrally 8 feet back from the east main wall (Fig. 5). A length of the conduit was also re-used. With its floor raised to a higher level and additional channels, it now formed a rectangle, its eastern section running behind the apse and continuing north and out through gaps in the main and verandah walls. Its function was now probably that of a drain to carry away the rain water from the open central courtyard.

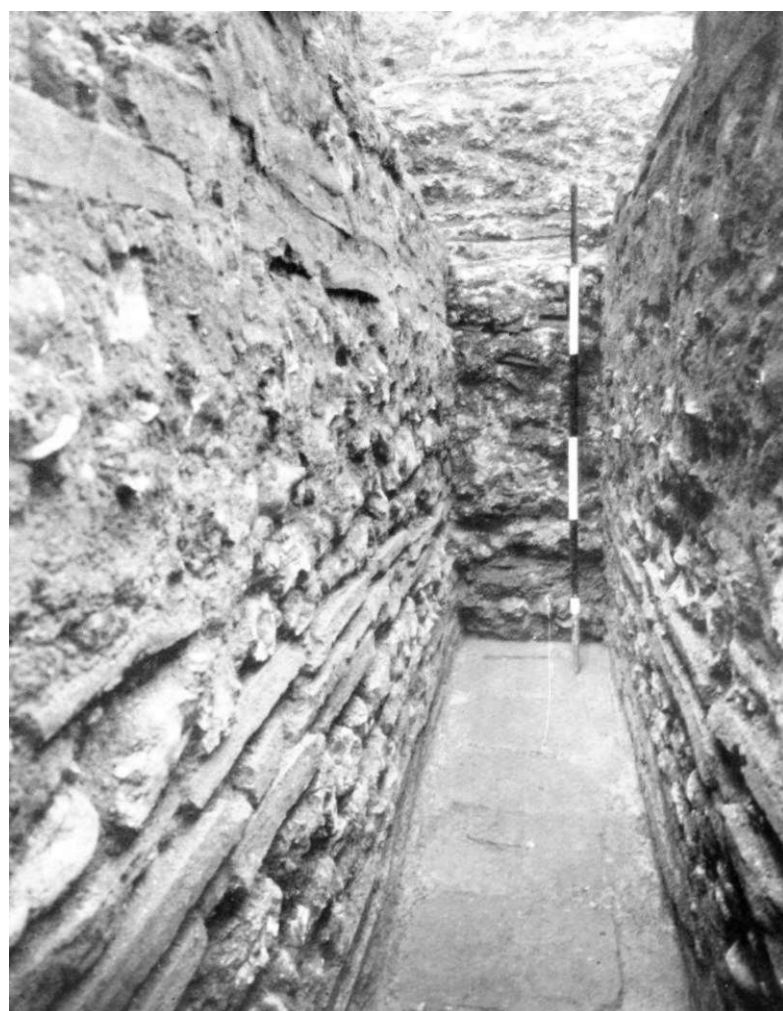
FIG. 3. PHASE III CONDUIT.

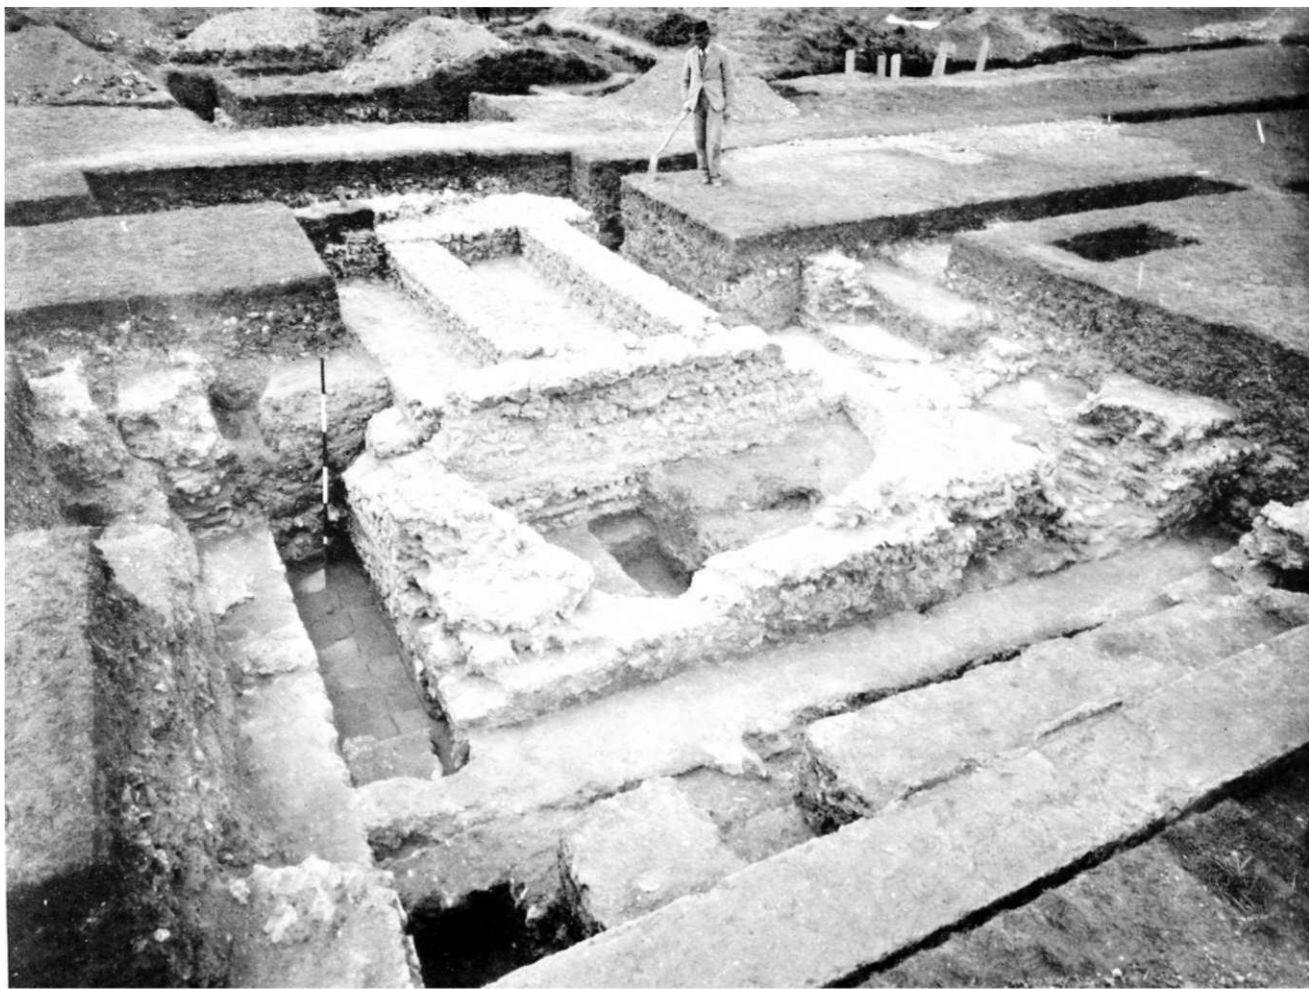
FIG. 5. PHASE III CONDUIT, PHASE IV DRAIN AND APSE AND MASONRY BLOCK OF PHASE

The third and last rebuild may easily be distinguished from the earlier phases by the coarseness of the masonry work, the somewhat slipshod building, and the heavy style of the new plan. At this stage further additions were made to the main plan (Fig. 4). A massive frontage now replaced the west verandah wall on Watling Street (Fig. 6). From this ran two walls with piers at 10 feet intervals, eight in all. The small rooms were presumably suppressed. The apse was also levelled; abutting on its west wall, however, and between the north and south drain walls was inserted a solid block of masonry 17 ft. 9 ins. by 10 ft. 3 ins. and some 8 ft. in depth, behind which ran a wall parallel to the outer east wall (Fig. 5). A similar block 14 ft. 6 ins. long was placed, again between the drain walls, 10 feet to the west of the first, and a

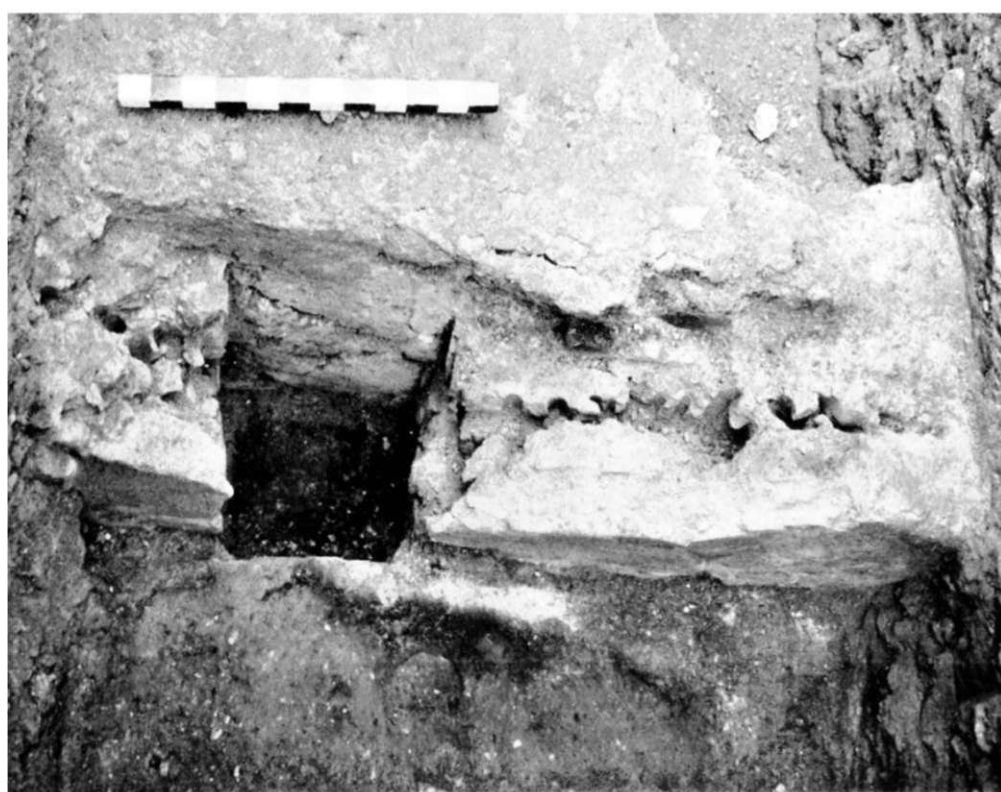
FIG. 7 WATTLE AND DAUB WALL OF WOODEN BUILDING PHASE II.

Stratified over the green gravel layer and covering almost all of the area excavated, there occurred a thick red layer consisting chiefly of daub burnt a brick red, and charred timbering. Although, owing to the overlying stone walls, the plan of a whole building could not be recovered, there was sufficient evidence to show that a fairly large wooden structure had existed, and that this had perished in a violent conflagration.
