Westminster Lodge Leisure Centre, St Albans, Hertfordshire

Archaeological Evaluation Report

Site Code WLC10

Report reference: 73320.04

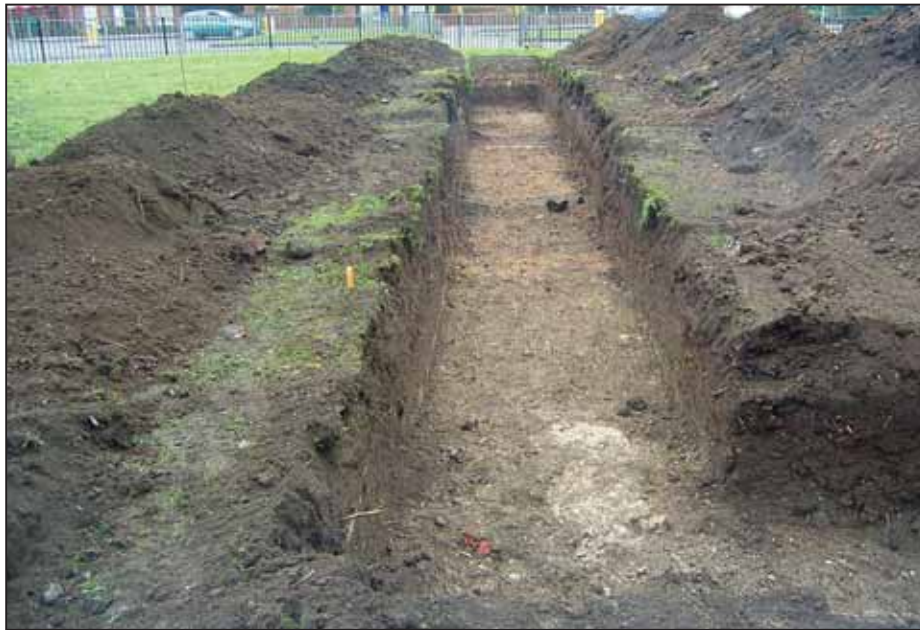
Plate 1: Overall view of Trench 10 from the west

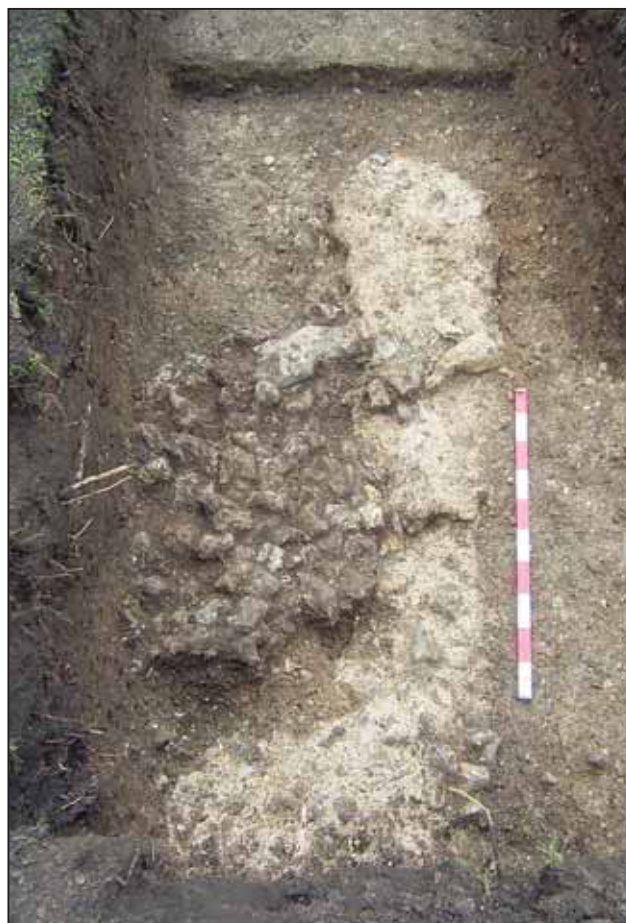
10010	Remains of the corner of a heavily robbed/truncated flint and mortar wall dating to RB period. Aligned NEE to SWW. Constructed of rounded partially dressed irregular coursed flint cobbles (<200mm) set in a yellow/white mortar.	0.80m
10011	Cut through 10013	1.15m+
10012	Fill of 10011 – Light greyish brown loose clayey silt. 60% stone flint inclusions subangular/subrounded. Some Roman CBM present. Possibly same as 10006	1.15m+
10013	Natural – mid brownish yellow loose sandy clay. 70% stone flint inclusions – subangular/subrounded <20mm	1.20m+
10014	Fill of 10015. Mid grey brown loose silty clay with 70% stone/flint inclusions <20mm	1.22m+
10015	?Pit. Cuts 10013	1.22m+
10016	Fill of Pit 10017 – Unexcavated. Mid brown gray friable sandy clay with % sub rounded/-angular flints (<50mm). contains CBM, RB pottery, animal bone and frequent charcoal	
10017	Large pit which post dates RB wall 10010. Filled with 10016 – Unexcavated.

Plate 2: Flint and mortar wall (10010), Trench 10, from the west

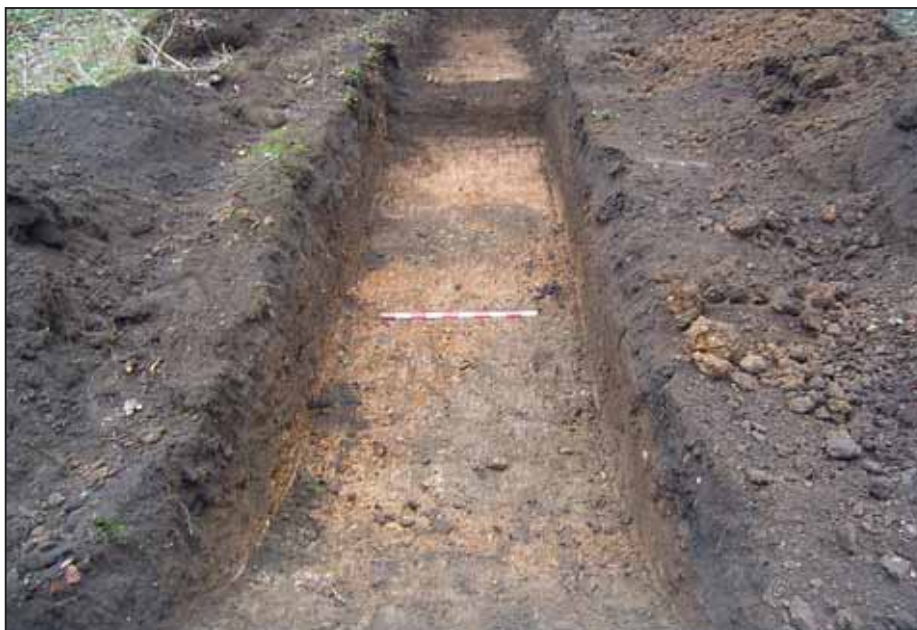
Plate 3: Ditch (11005) and pit (11007), Trench 11, from the north east

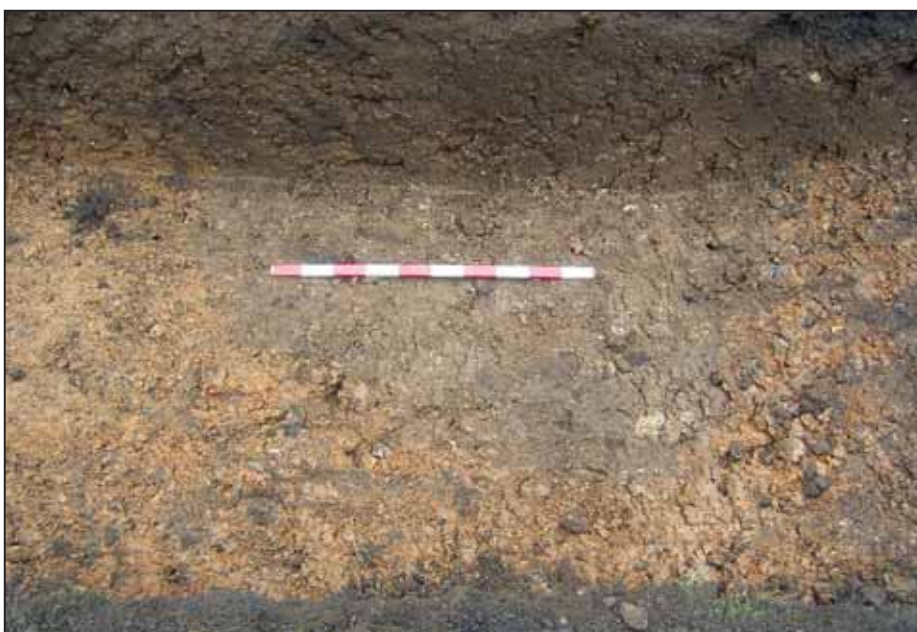
Plate 4: Pit (11007), Trench 11, from the east

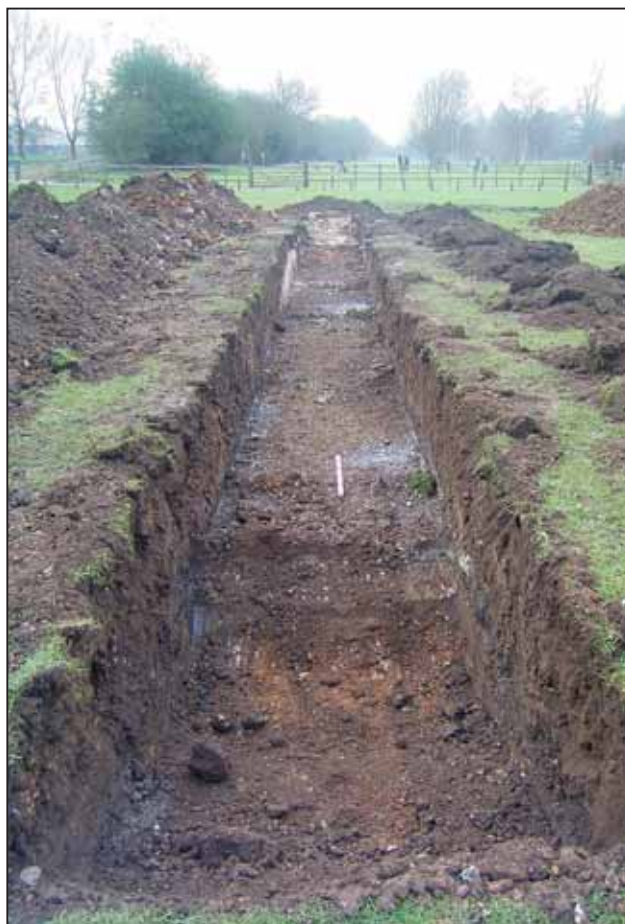
- 4.3.2 **Trench 2 (Figure 1)** was located c.10m to the east of Trench 1 and was aligned from north east to south west. It measured 20.90m long by 1.60m wide with an average depth of 0.70m. The soil sequence was very similar to Trench 1 with four layers of heavily compacted made ground beneath a thin layer of topsoil. At the northern end of the trench a sondage was excavated through the compacted ground, using a mechanical breaker, to a depth of 1.20m. The natural geology was reached at a depth of 1.05m and consisted of yellowish brown sandy gravel. No archaeological remains were present.

Plate 5: Trench 2 from the north

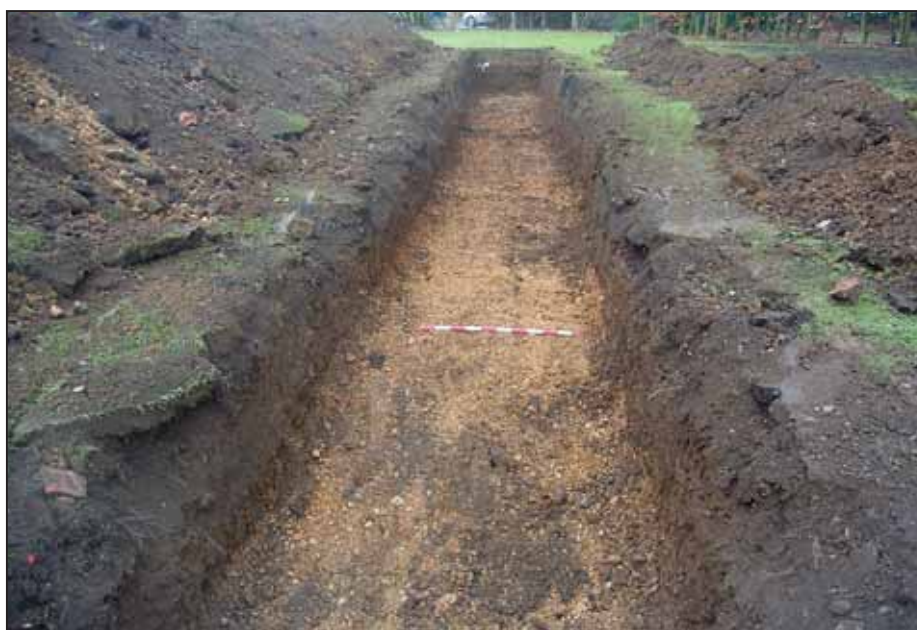
Plate 6: Trench 12 from the south east
