ST ALBANS & HERTFORDSHIRE
Architectural & Archaeological Society

The Renovation of the "Christopher Inn," French Row, St. Albans, 1950-54

A. S. MOODY, A.M.I.C.E., M.INST.M.E., A.M.T.P.I.
City Engineer and Surveyor

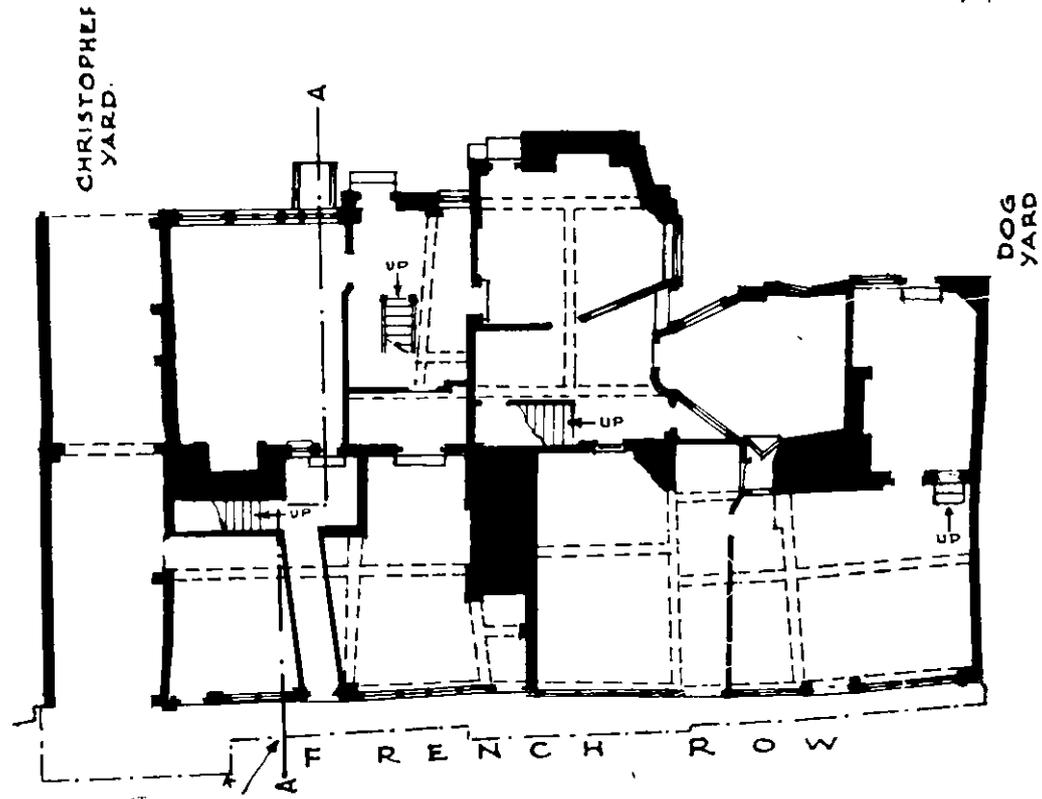
LINE OF 1ST FLOOR GROUND FLOOR PLAN.
 BEFORE ALTERATION.
 SCALE 12 FT. TO 1 INCH.

of the sixteenth century. The block QTUV, with its chimney-stack Y is the nucleus of this house, which seems to have been originally quite separate from the Inn. The dimensions of the stack Y suggest that there were a room or rooms west of it, but those which existed in 1951, EFGU, were of eighteenth-century character with two separate gables running east to west. The

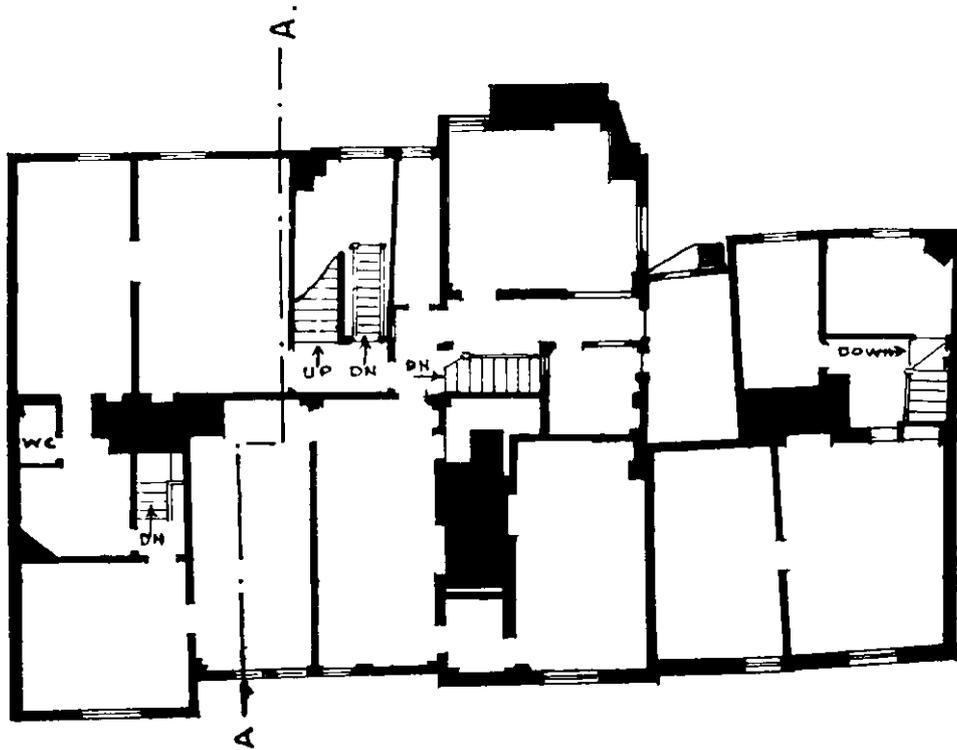
FIRST FLOOR PLAN.
 BEFORE ALTERATION.

On the first floor the partition between the room over the entry and the main room (shown in the section A-A) is substantially original, with a curved brace at each end: the partition on the line MR also has a curved brace at each end. The wall, LM, had evidence of one and perhaps two original doorways indicating that access to the first floor was from a gallery on the courtyard side, and indeed there was a beam in position which might have supported such a gallery. The chimney-stack, X, is probably an original feature, though perhaps enlarged when MNOP was added.
